**ASEAN-JAPAN COOPERATION
ON MATERIALS SCIENCE AND TECHNOLOGY**

**SEMINAR ON CORROSION
AND PROTECTION**

BANGKOK , THAILAND

17-19 OCTOBER 1990

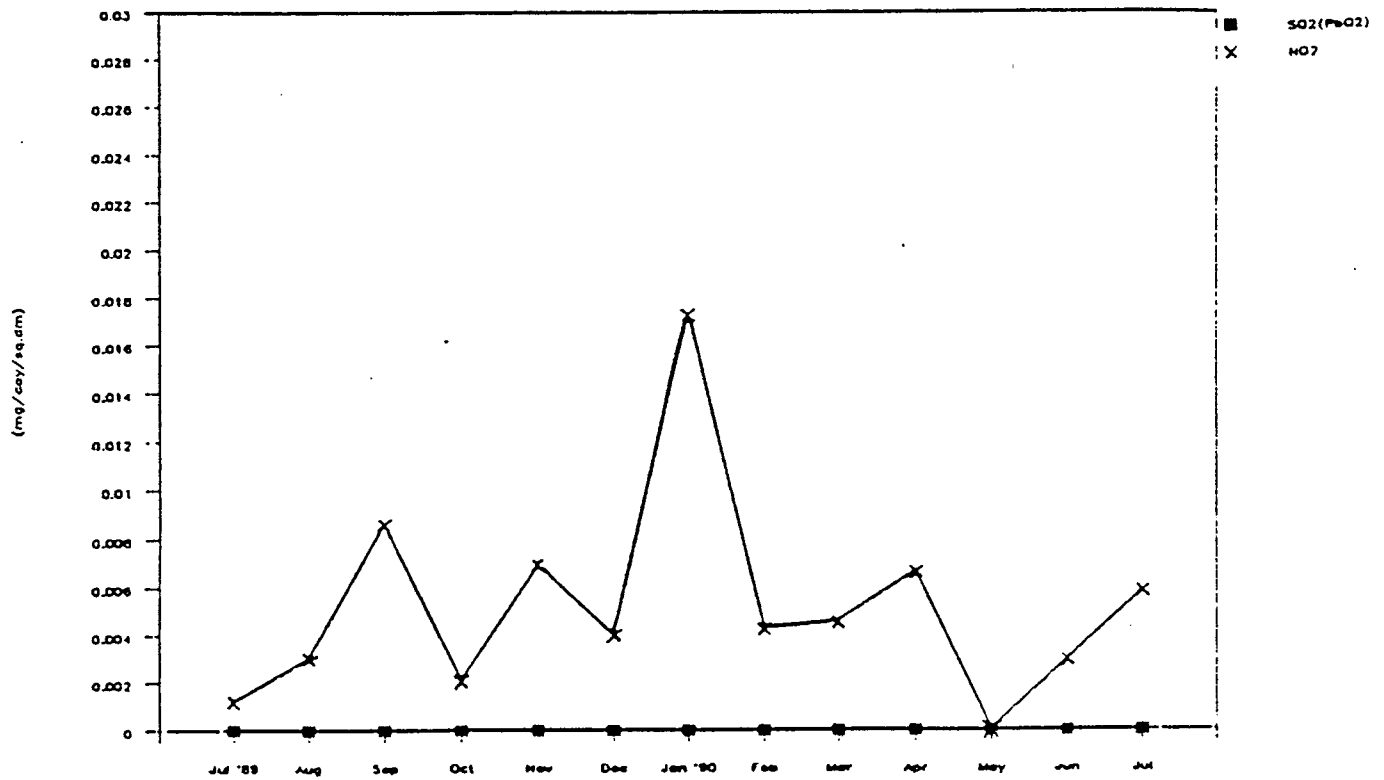
FIG. 4 SITE 12 HUA-NINIJICA : RESULT OF ATMOSPHERIC POLLUTANT ANALYSIS
OF SO₂ (PbO₂) AND NO₂ MONTHLY AVERAGE

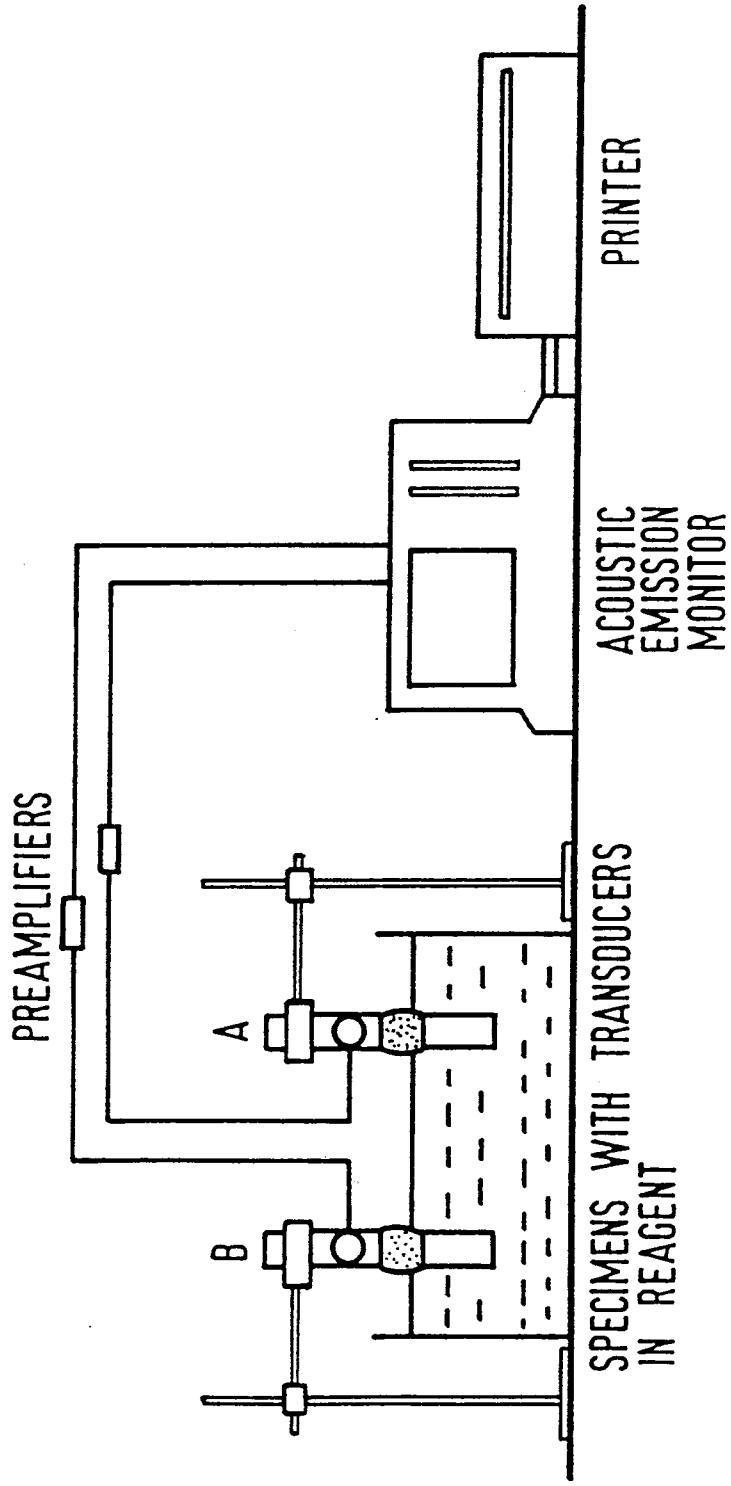
Fig.1 Experimental setup

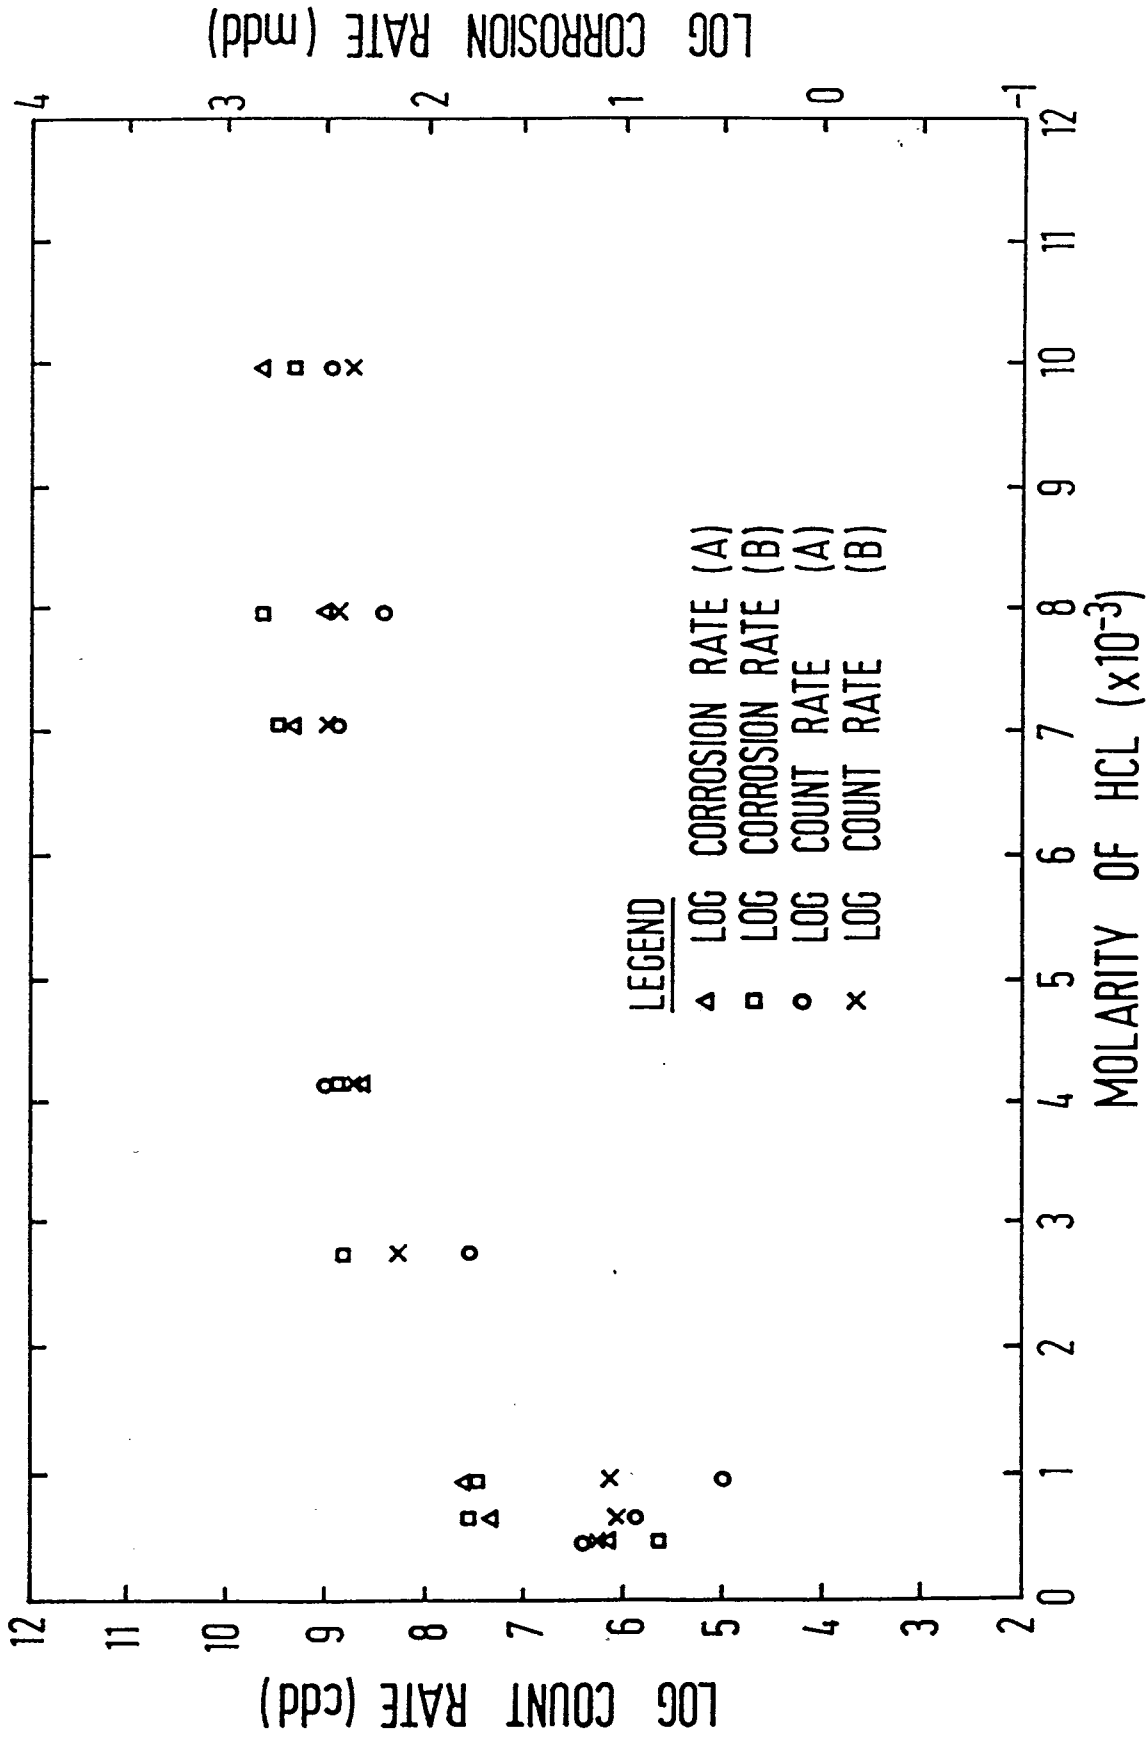
Fig.4 Log A.E. Count Rate And Log Corrosion Rate Vs Molarity Of Hydrochloric Acid

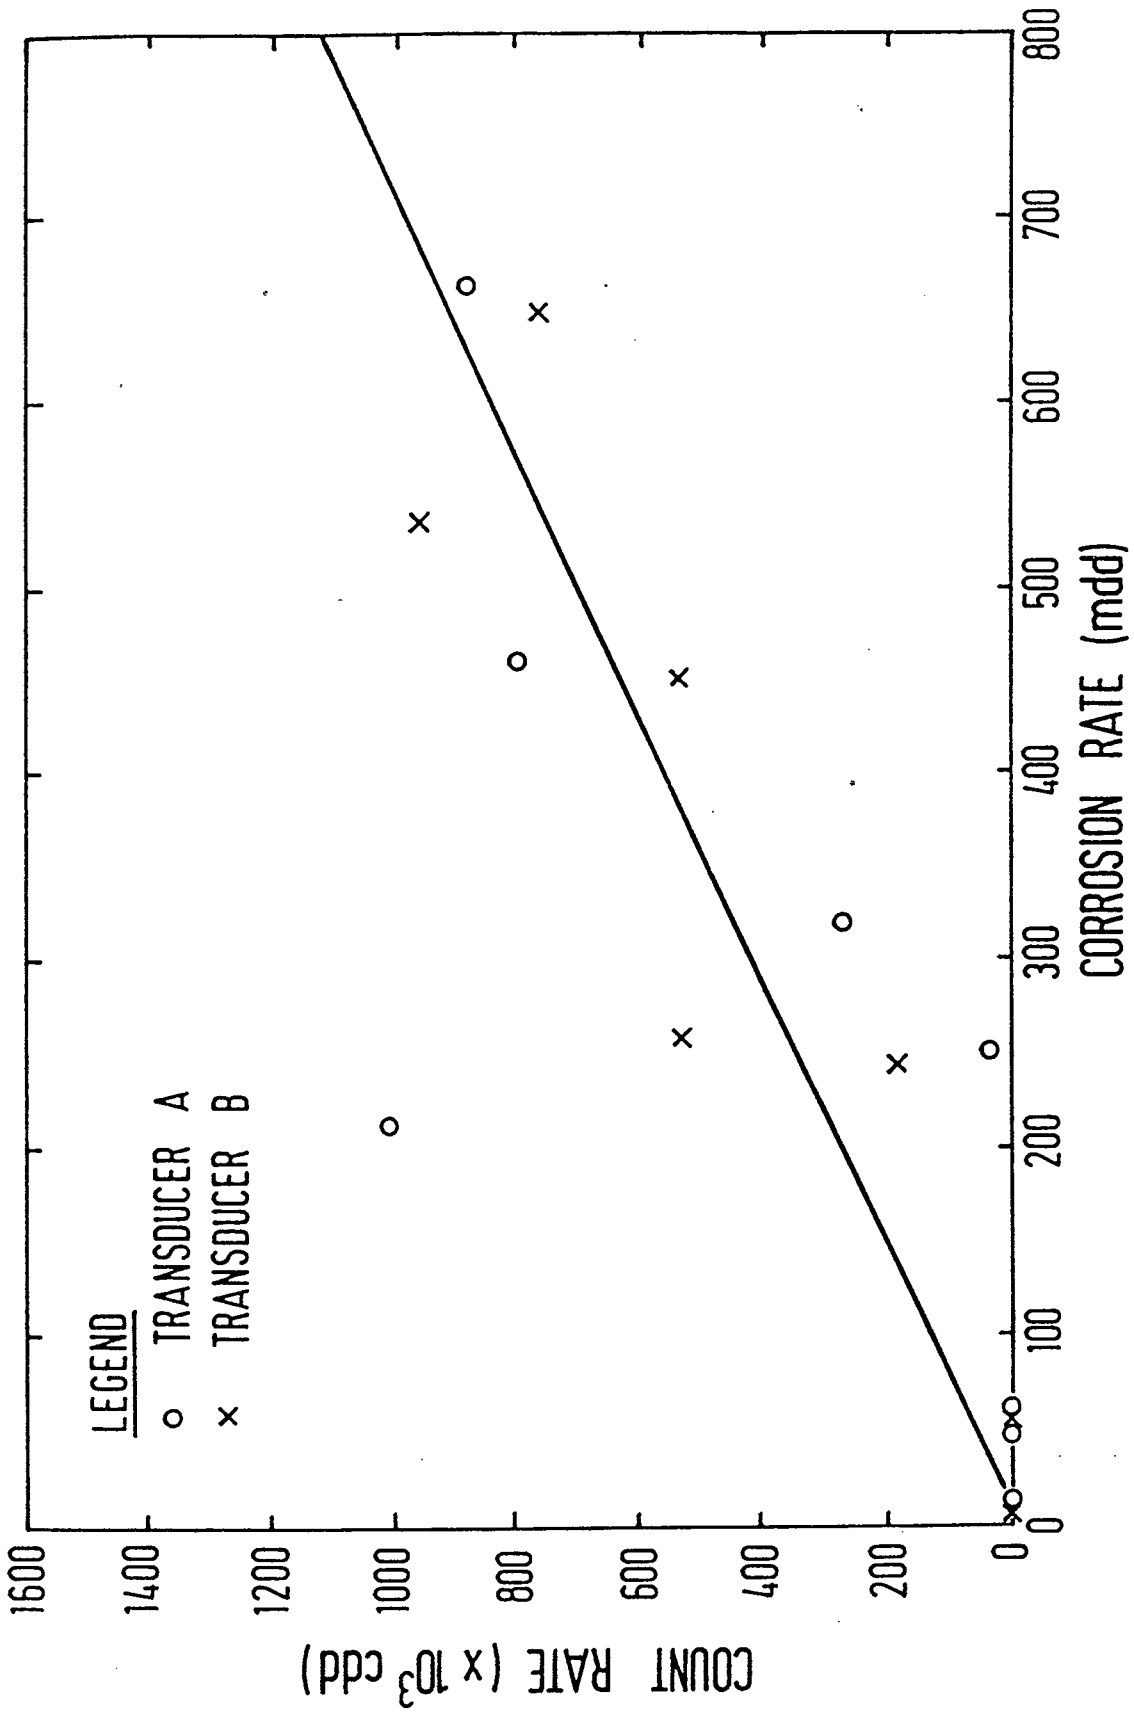
Fig.5 A.E. Count Rate Vs Corrosion Rate

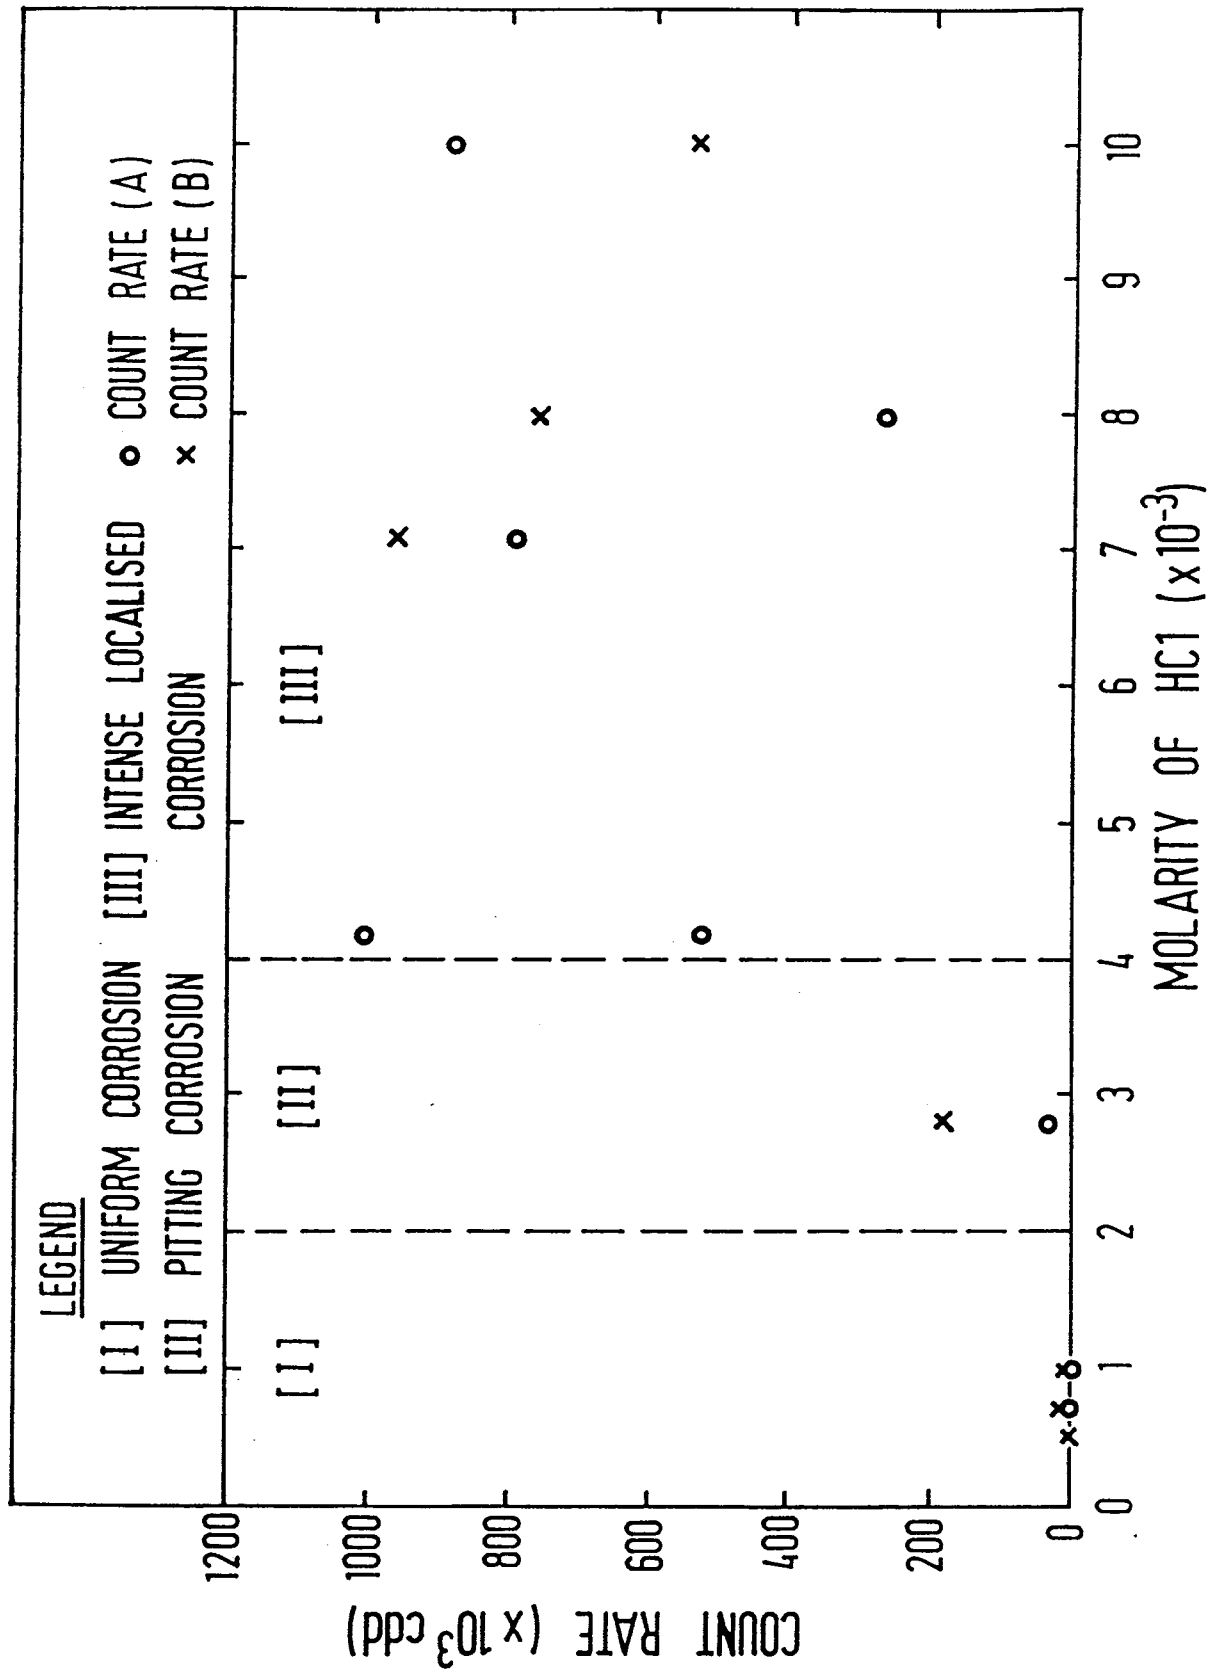
Fig. 6 A.E. Count Rate Vs Molarity Of Hydrochloric Acid

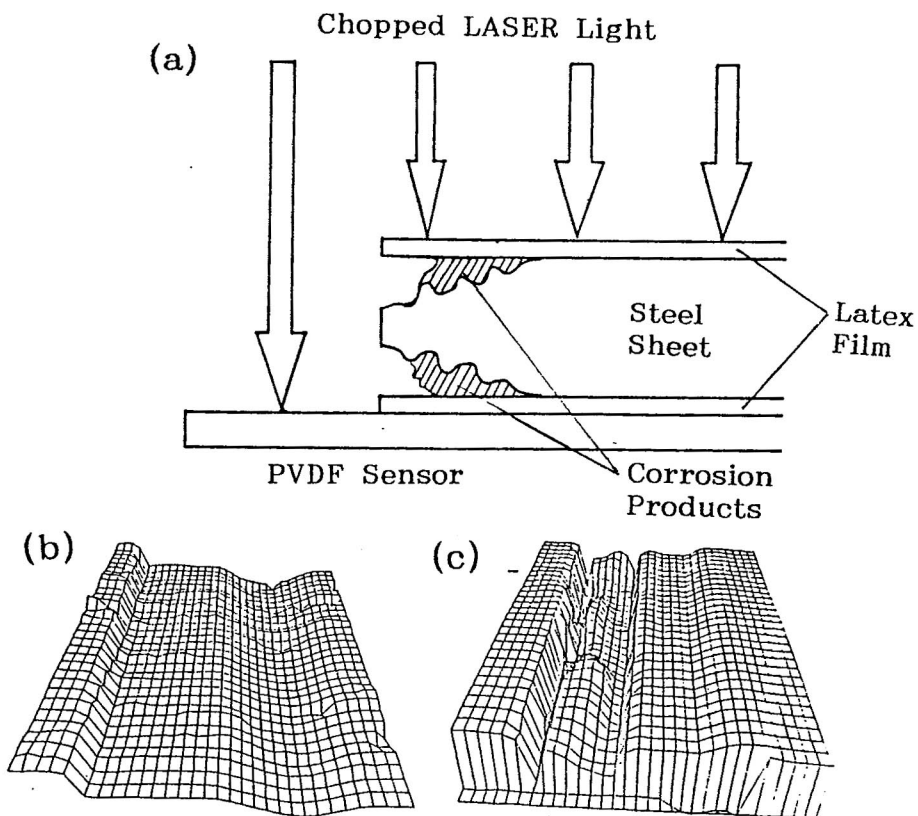
Fig.5 (a) Scheme of cross section of the latex coated steel corroded from the edge, (b) PA signal image before corrosion and (c) after corrosion.

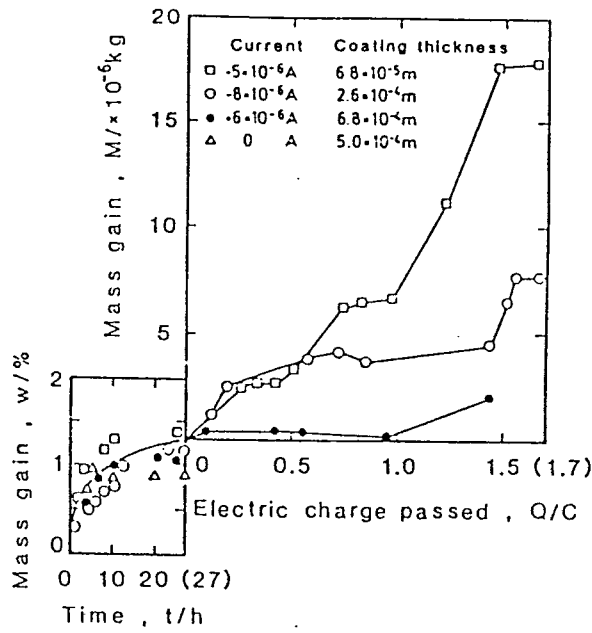
Fig. 1 Absorption of water by an epoxy-coated steel in 3% NaCl solution with or without the presence of electric current. Specimen : surface area ; 32 cm^2

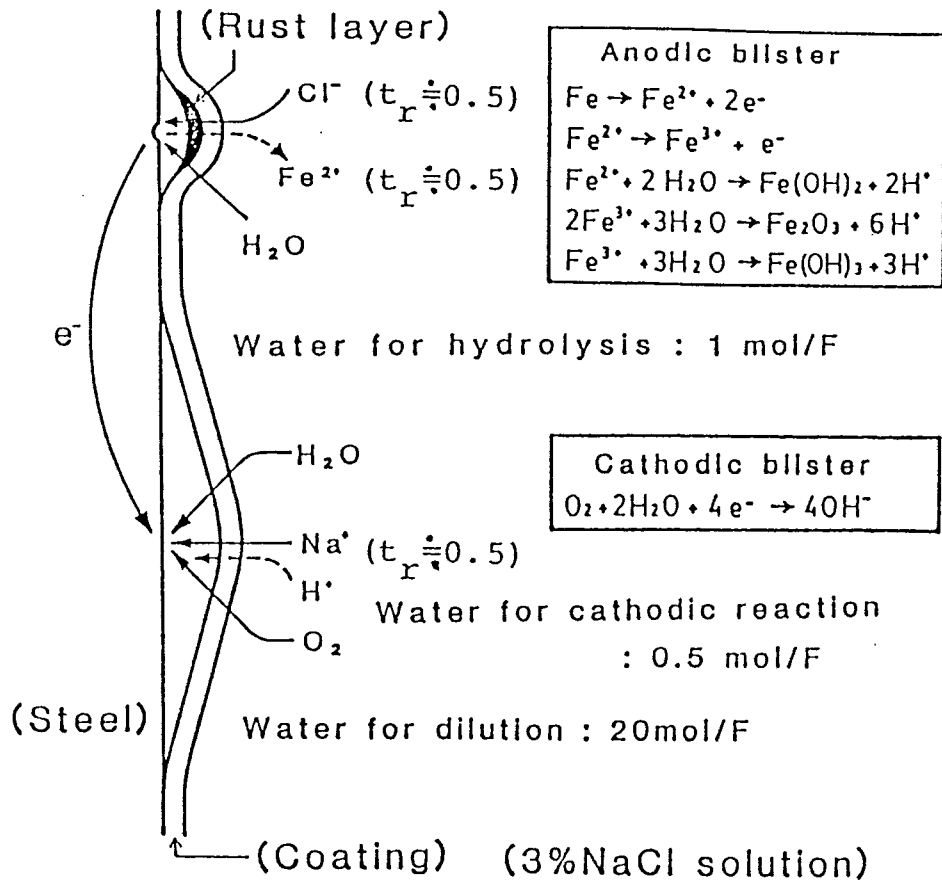
Fig.9 Transport of chemical species during blistering of coated steel.

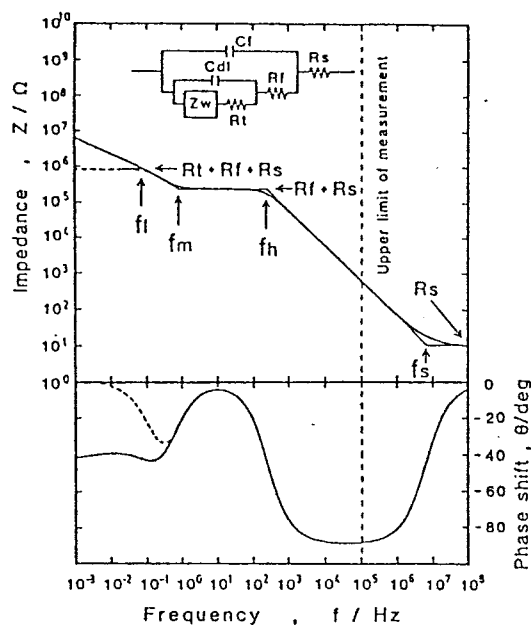
Fig. 1. Equivalent circuit for impedance diagram for degraded coated steel
 $R_s=10 \text{ ohm}$, $R_f=2.5 \cdot 10^5 \text{ ohm}$, $R_t=6.5 \cdot 10^5 \text{ ohm}$,
 $C_f=2.4 \cdot 10^{-4} \text{ F}$, $C_{d1}=1.6 \cdot 10^{-6} \text{ F}$, $\sigma=3.4 \cdot 10^5 \text{ ohm}$

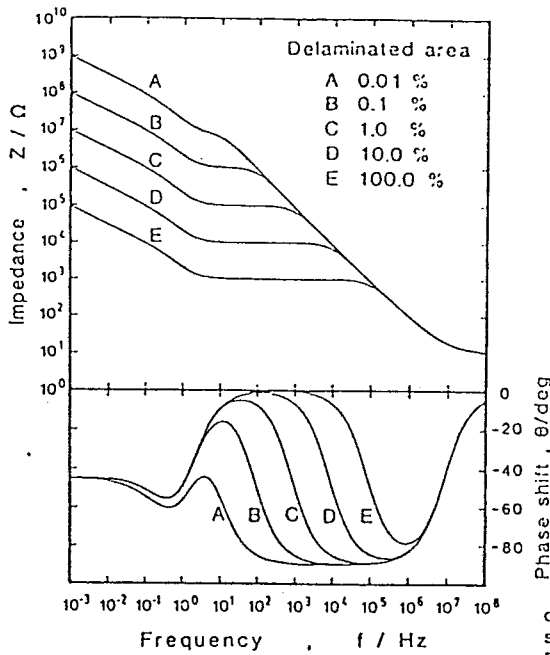
Fig. 6. Computer simulation of impedance characteristics of degraded coated steel $R_s=10 \text{ ohm}$, $C_{dl} S_0=2 \cdot 10^{-9} \text{ F}$, $C_{dl} S_0=1 \cdot 10^{-4} \text{ F}$, $R_f/S_0=1000 \text{ ohm}$, $R_t/S_0=5000 \text{ ohm}$, $\sigma_0/S_0=5000 \text{ ohm}$. Numbers indicate S/S_0

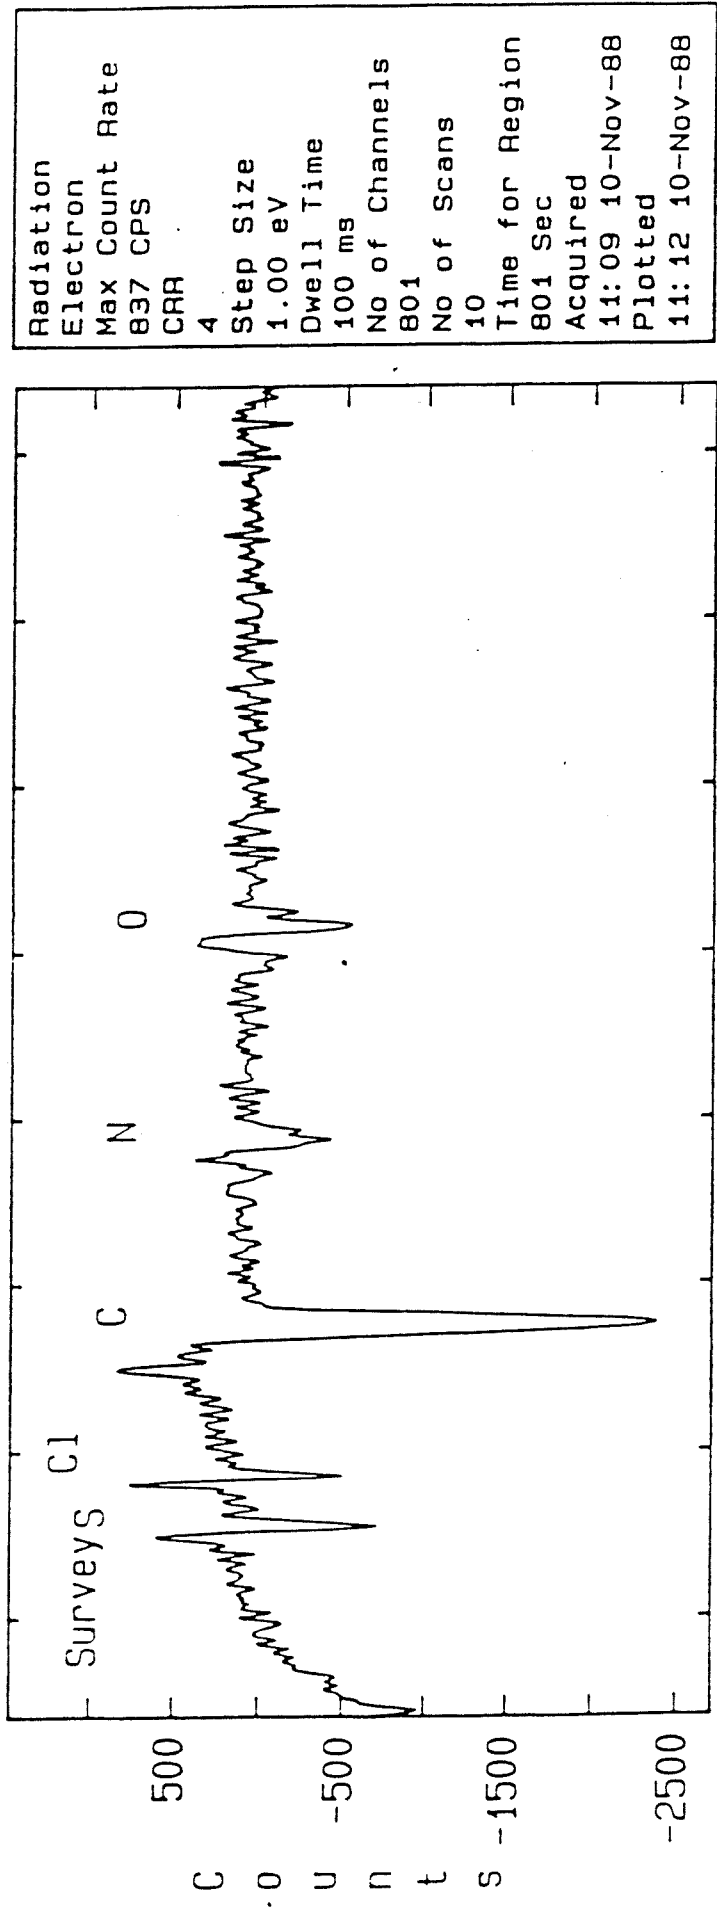
Fig. 10 : Analysis of the Surface of Mild Steel Immersed in a Solution of Saturated Lead Azelate + 10⁻³M Chloride.
 (Corrosion Product Around Pit)

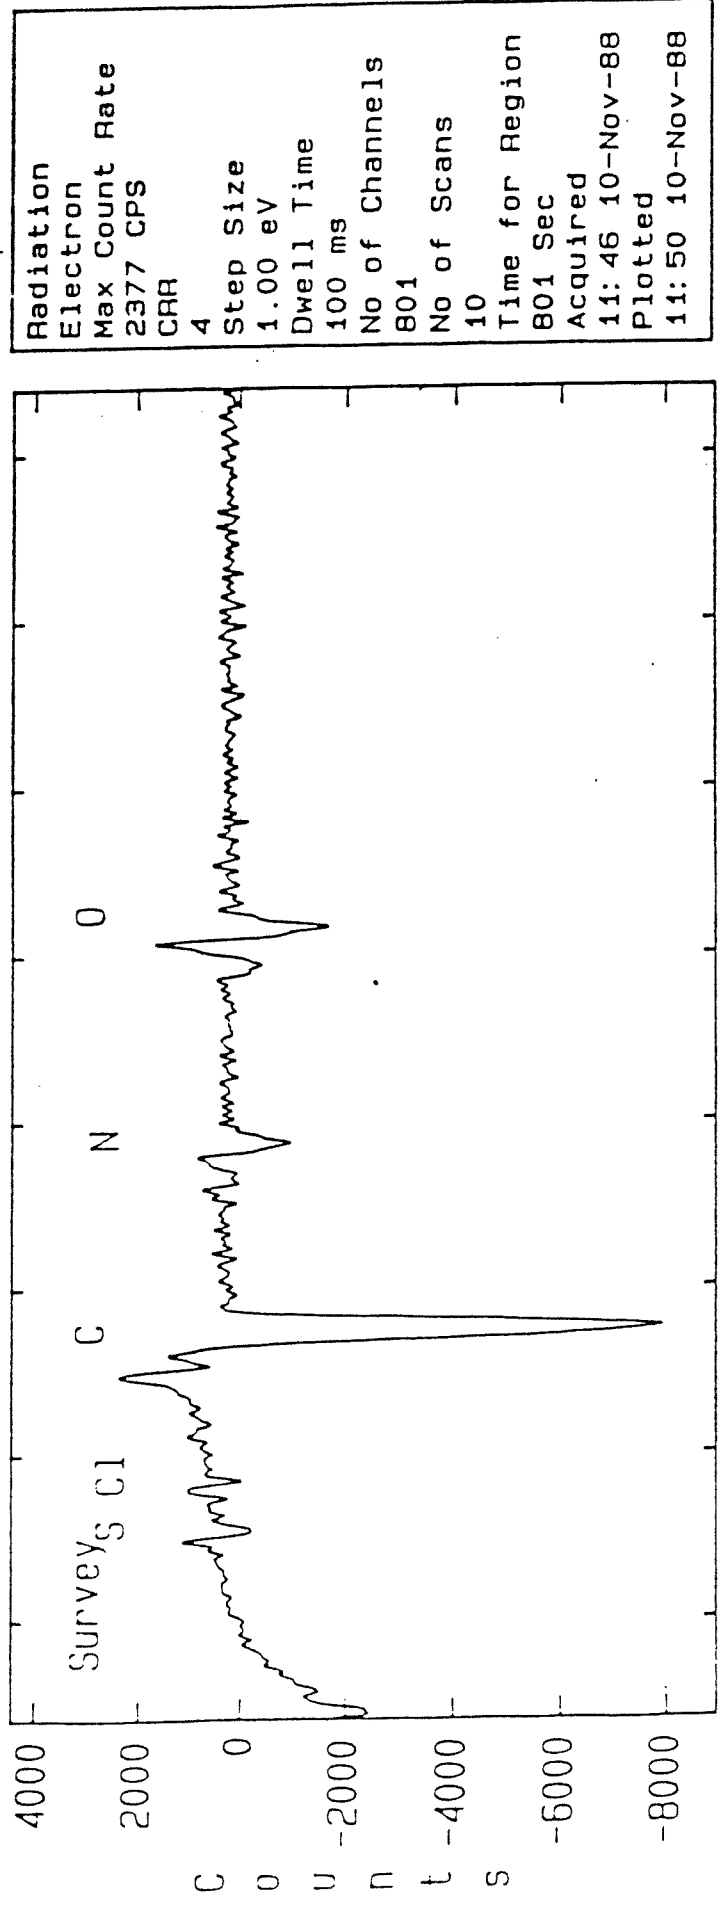
Fig. 11 Analysis of the Surface of Mild Steel Immersed in a Solution of Saturated Lead Azelate + 10^{-3} M Chloride.
(Dark Stain Surrounding Corrosion Pit)

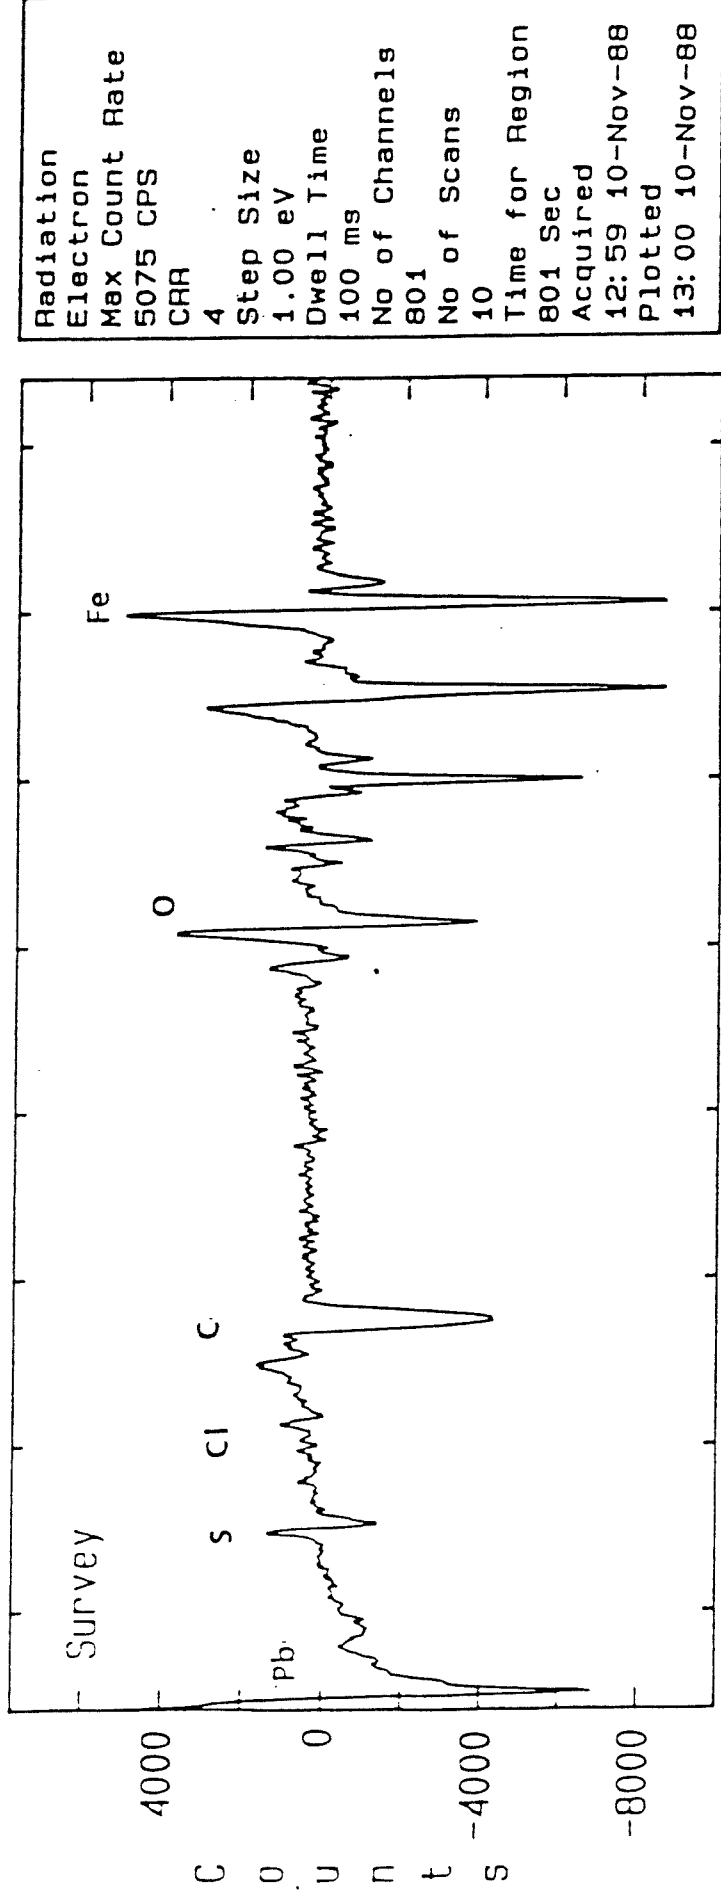
Fig. 12 : Analysis of the Surface of Mild Steel Immersed in a Solution of Saturated Lead Azelate + 10^{-3} M Chloride.
 (Dark Stain, After Light Etch)

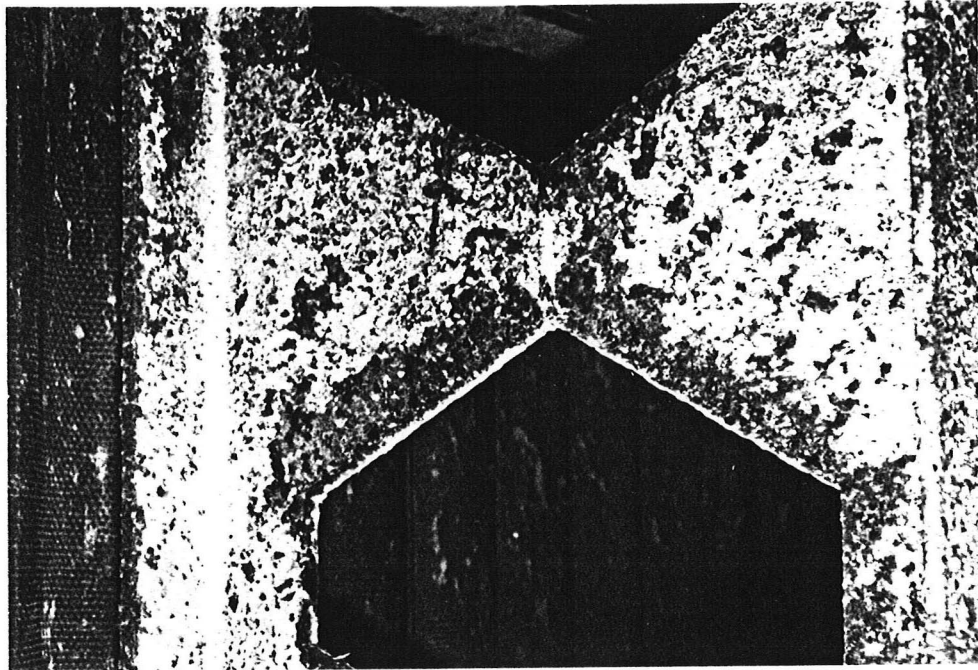
Fig. 1 Flaking off of loose paint

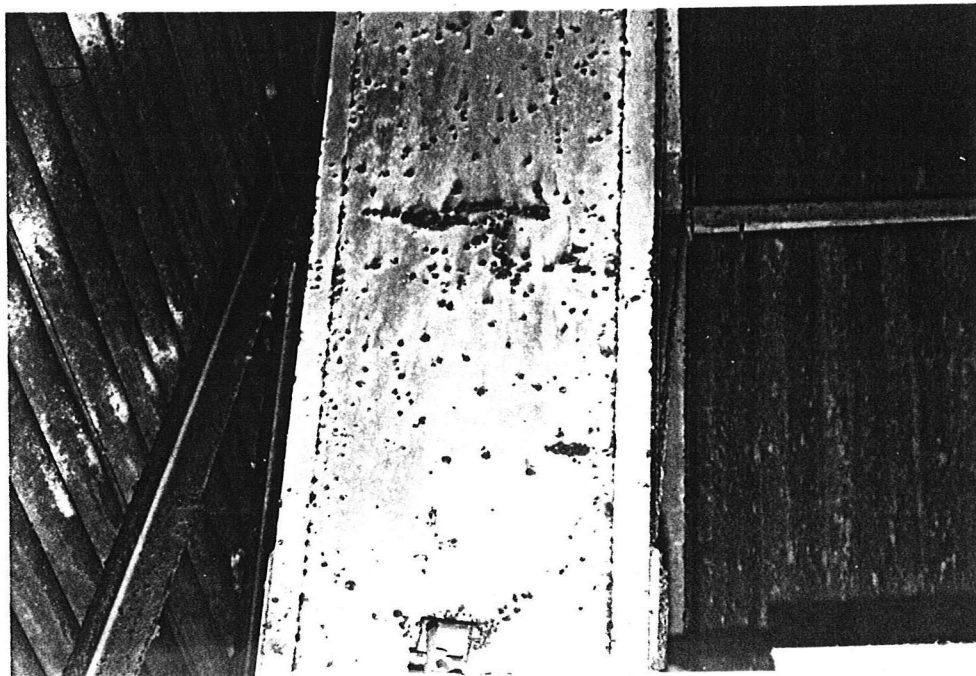
Fig. 2 Severe blistering in steel structure

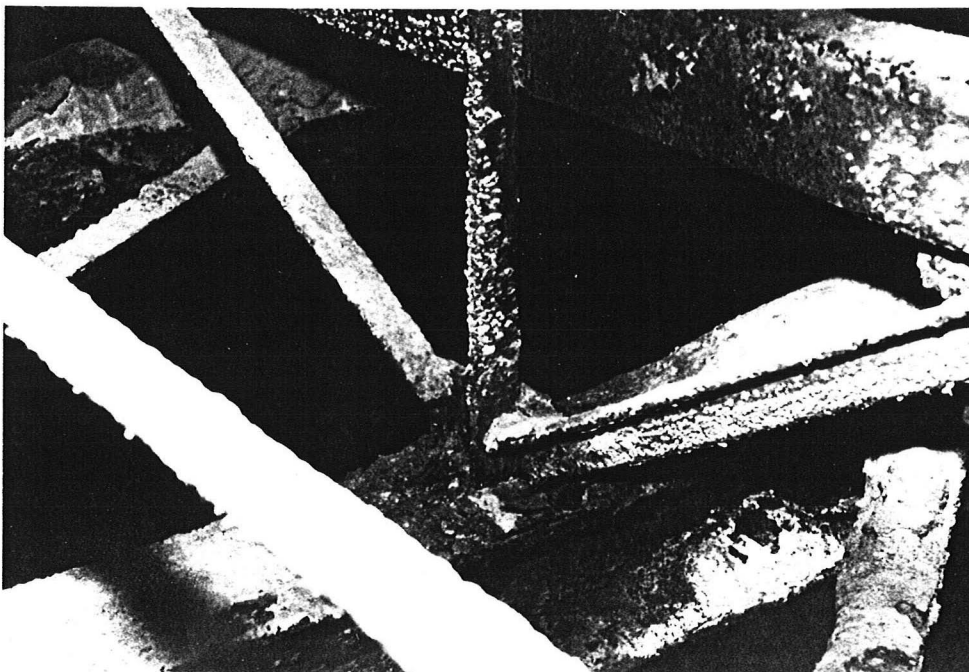
Fig. 4 Corrosion at the joints due to collection of dirt, moisture and contaminants

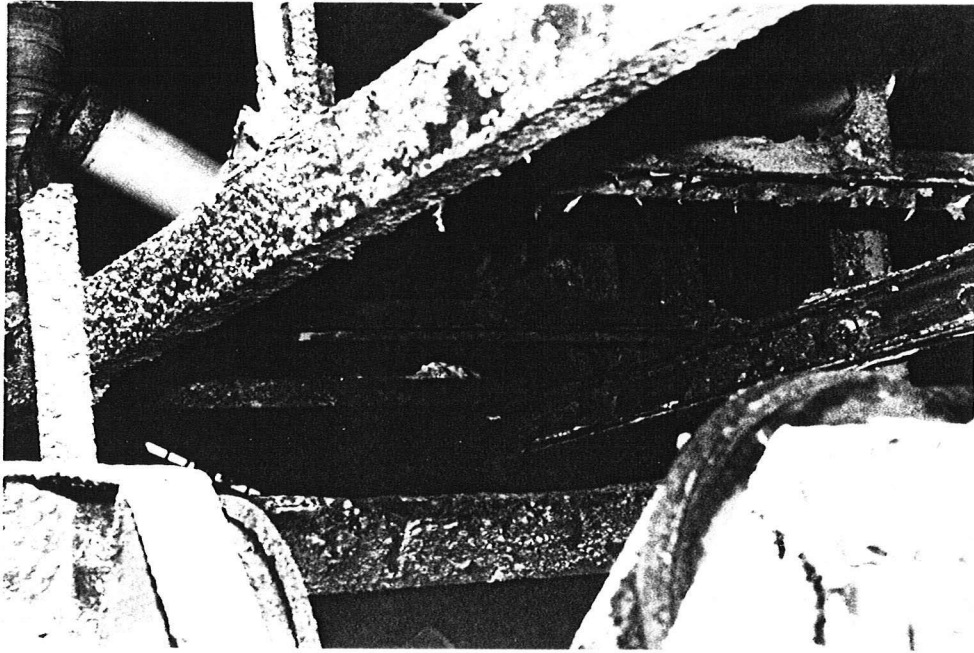
Fig. 5 Corrosion occurring below the conveyor belt

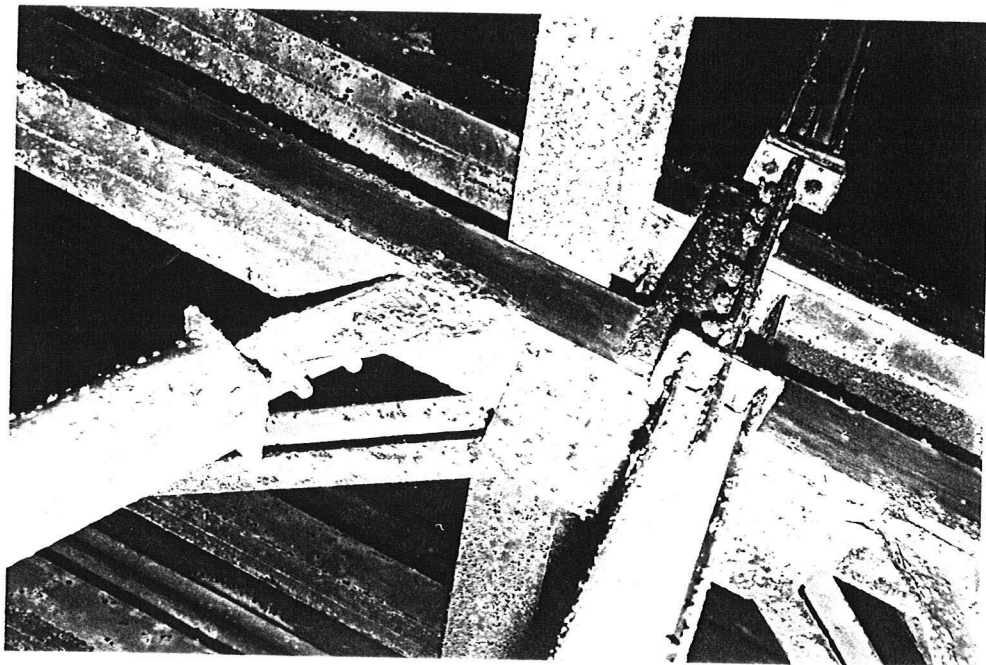
Fig. 6 Joints provided ideal sites for corrosion

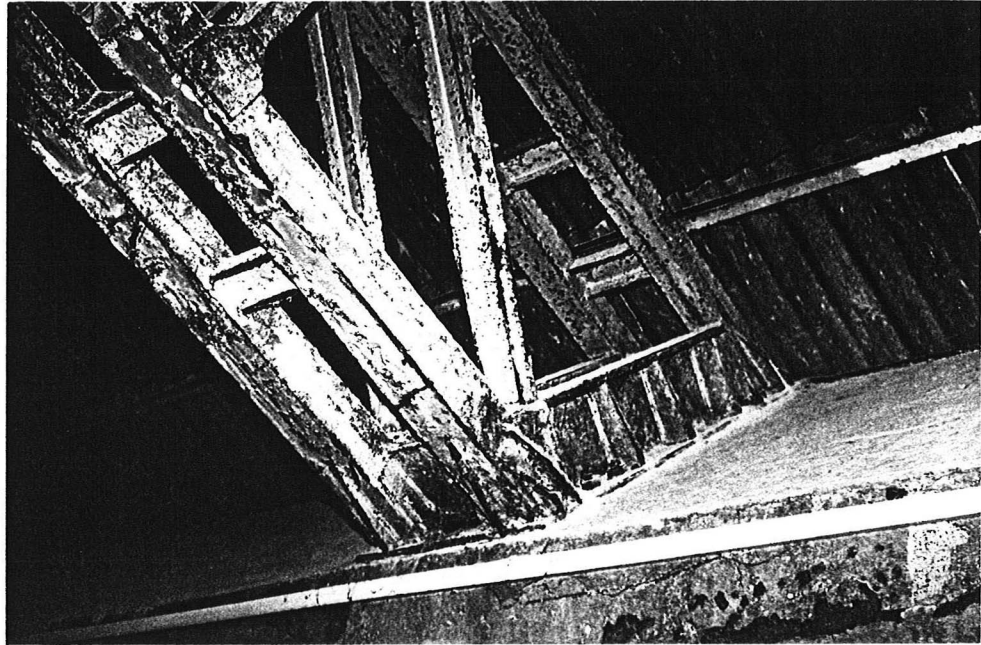
Fig. 7 Corrosion on the roof support framework

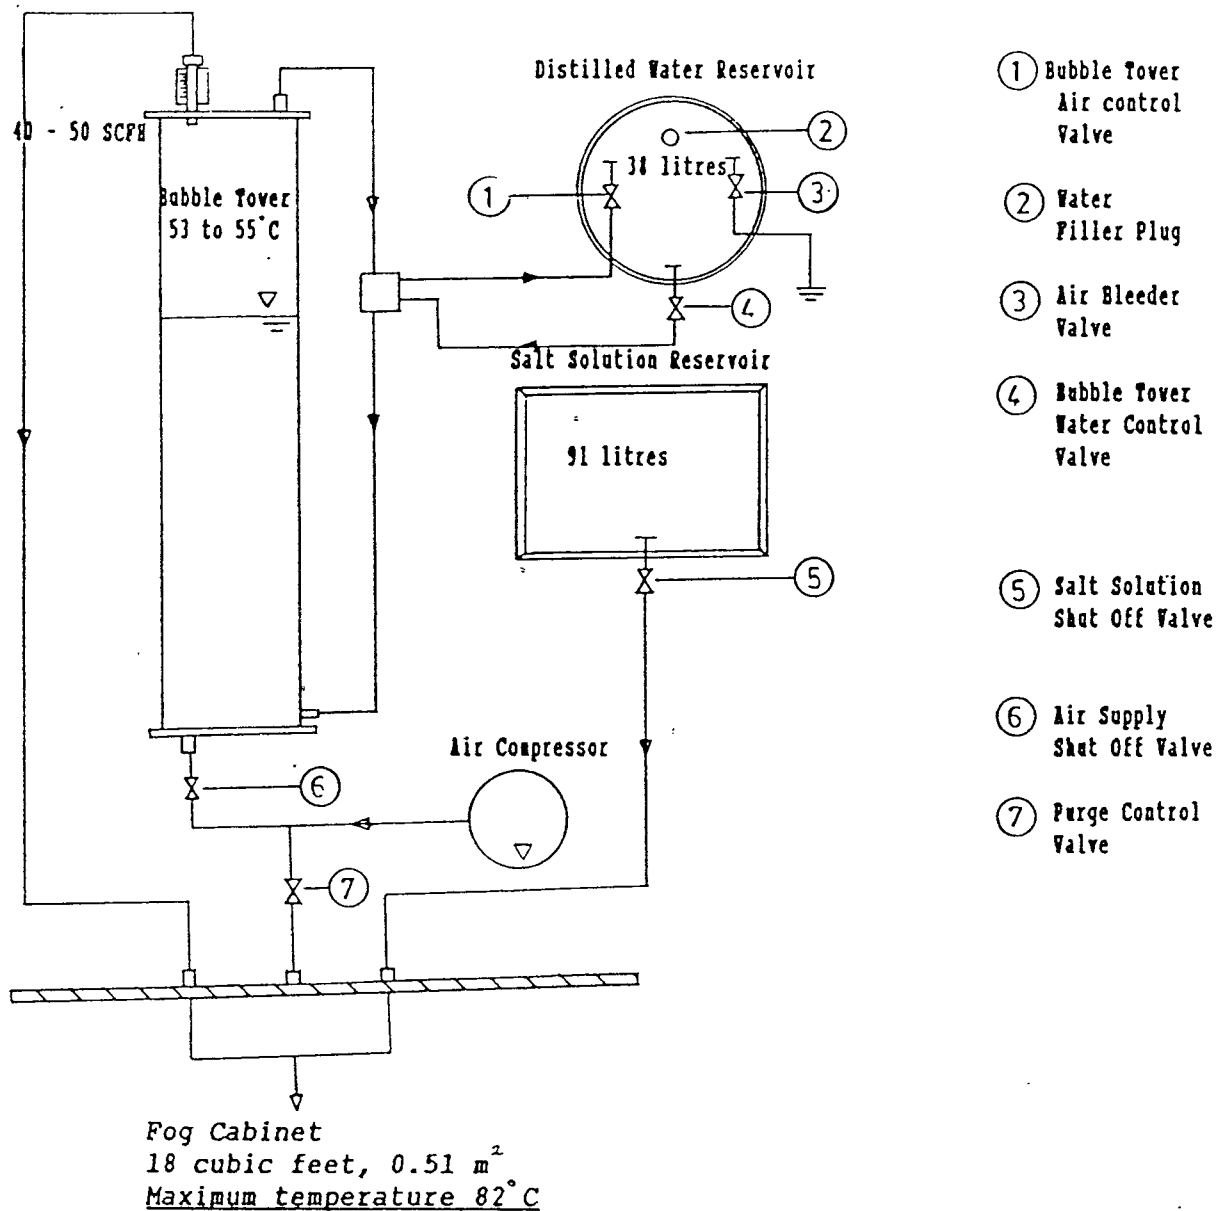
Fig. 8 Schematic diagram of the salt spray exposure system

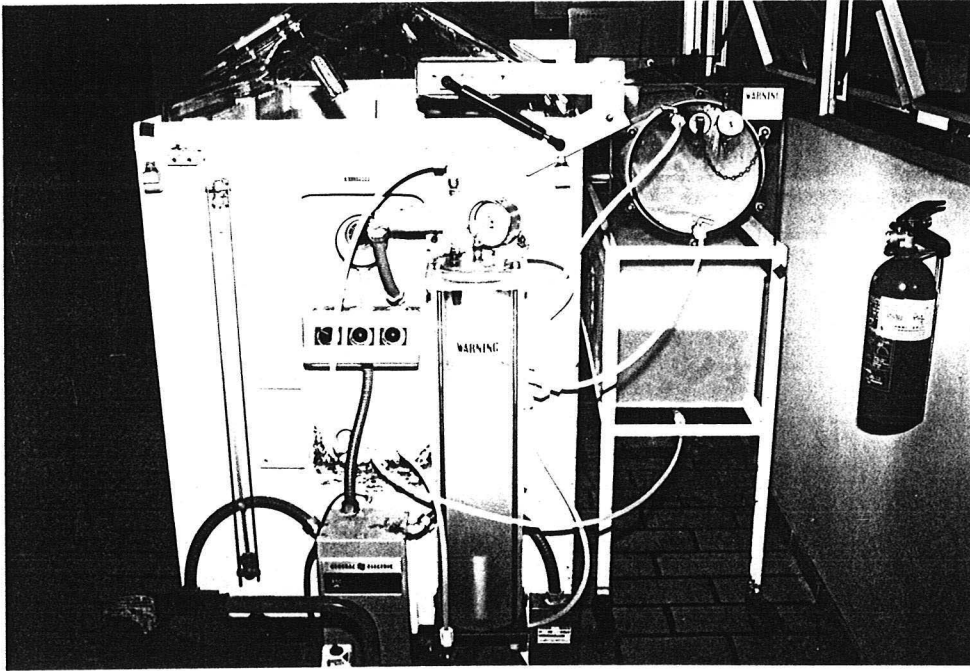
Fig. 9 An overall view of the corrosive fog exposure system

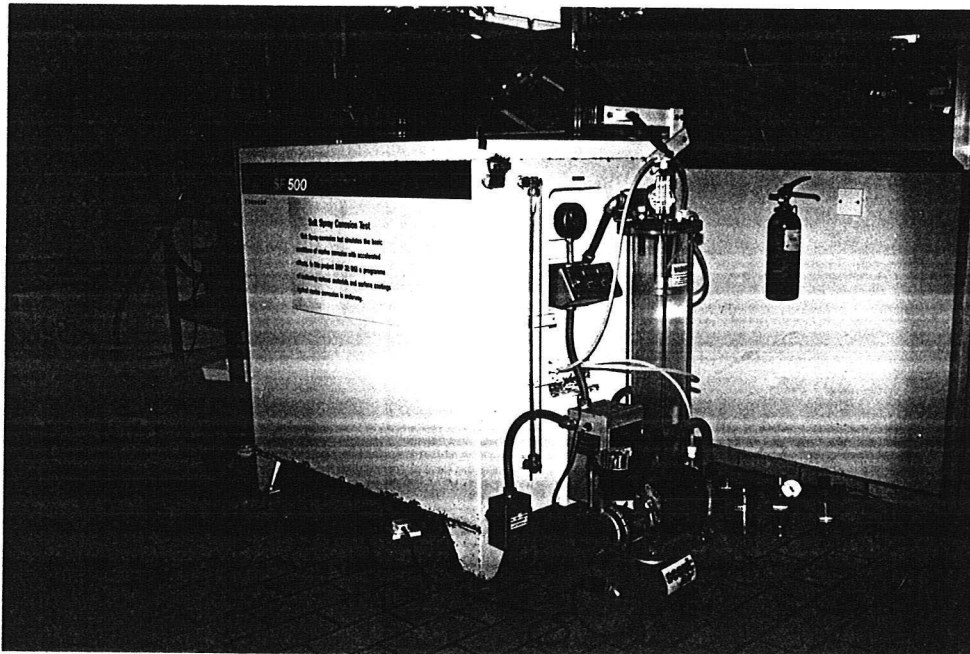
Fig. 10 Another view of the salt spray system

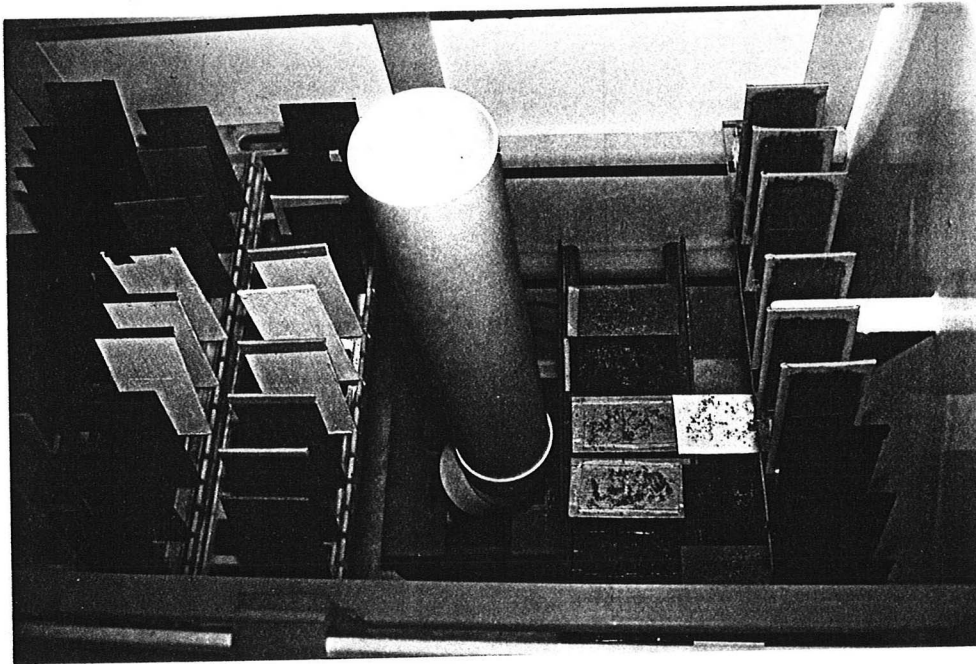
Fig. 11 Test specimens in the salt fog cabinet

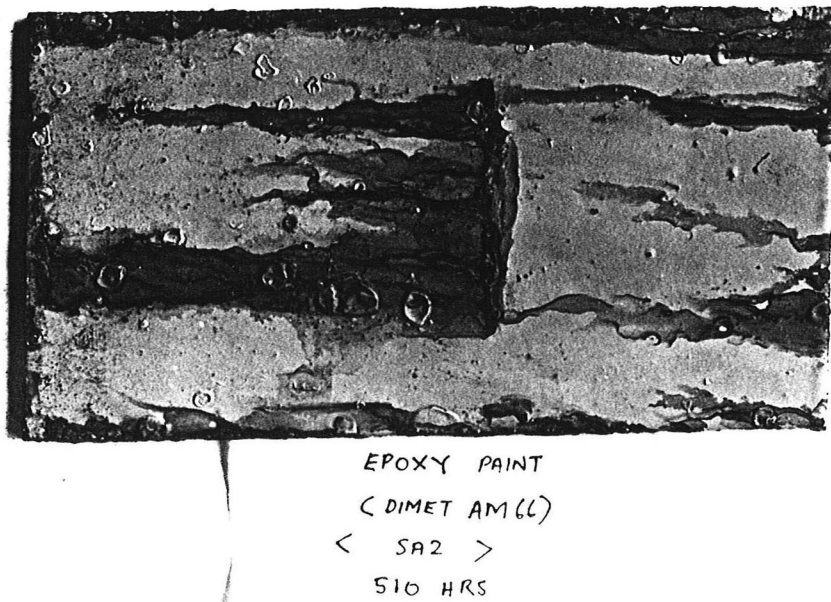
Fig. 13 Formation of blisters on salt spray exposure. Epoxy AM 66 paint coating on a SA 2 surface after 510 hrs
