**ASEAN-JAPAN COOPERATION
ON MATERIALS SCIENCE AND TECHNOLOGY**

**SEMINAR ON CORROSION
AND PROTECTION**

BANGKOK , THAILAND

17-19 OCTOBER 1990

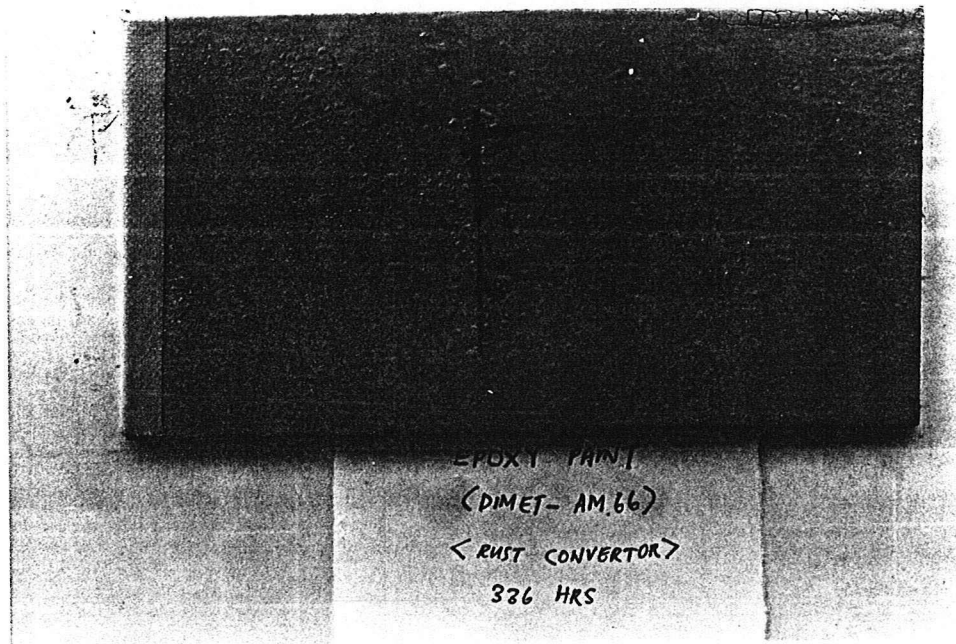
Fig. 14 Epoxy AM 66 paint coating on stabilized rust surface after 336 hrs.
Formation of numerous small sized blisters

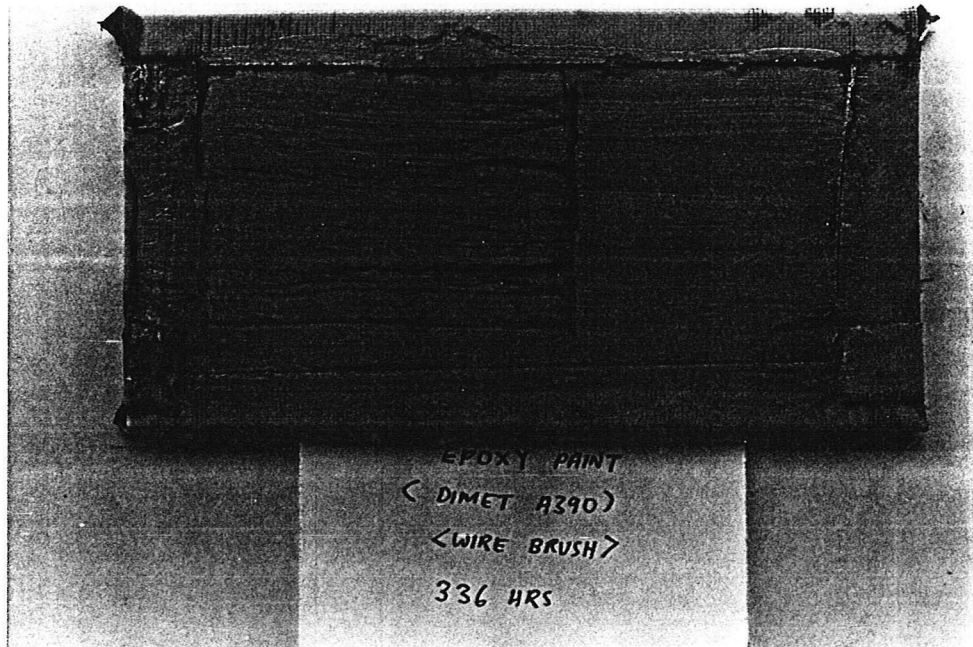
Fig. 16 Epoxy A 390 paint coating on a wire-brushed surface after 336 hrs of salt spray exposure. Minimal blistering effect but increasing corrosion rate with increasing time.

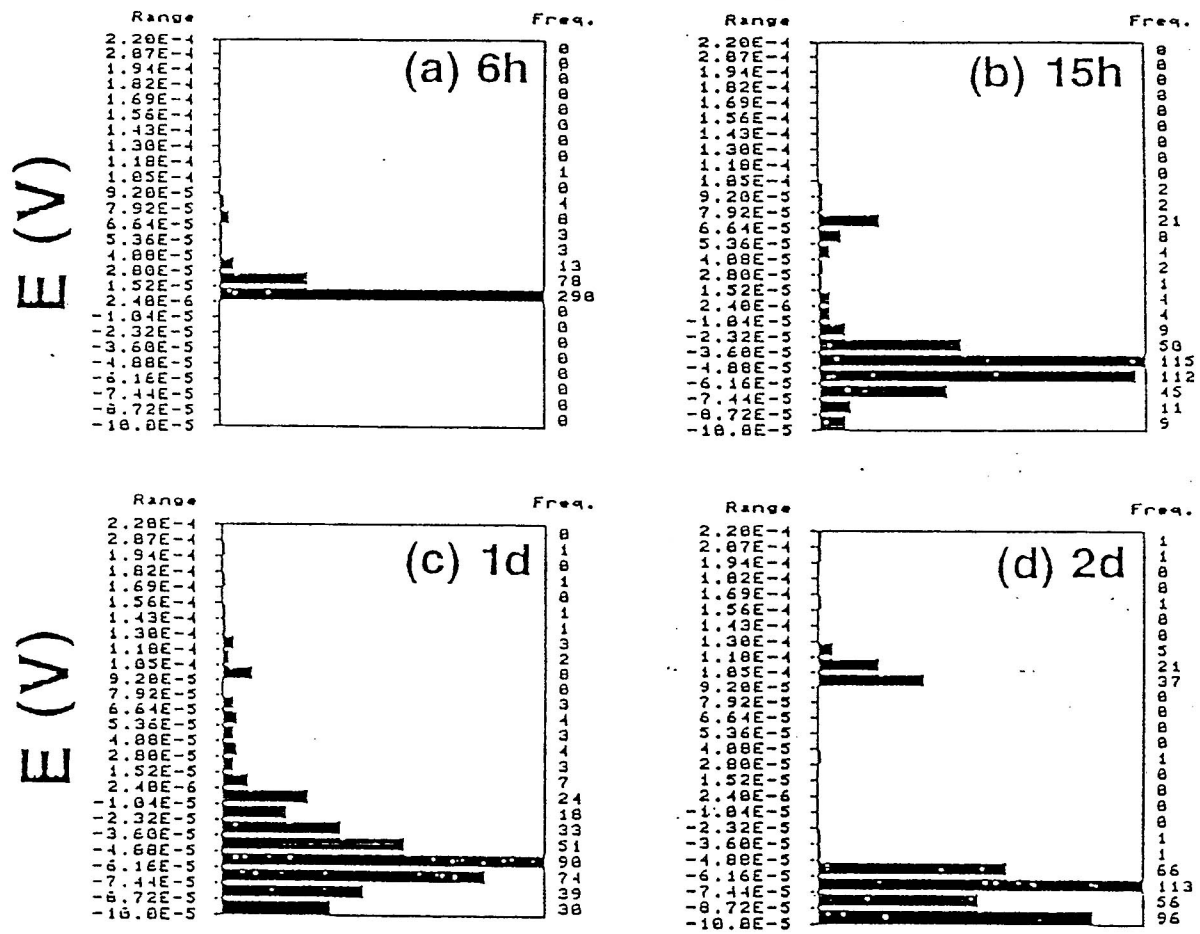
Fig.5 Distribution of E for Ep paint film.
Immersion time: a;6h, b;15h, c;1d, d;2d

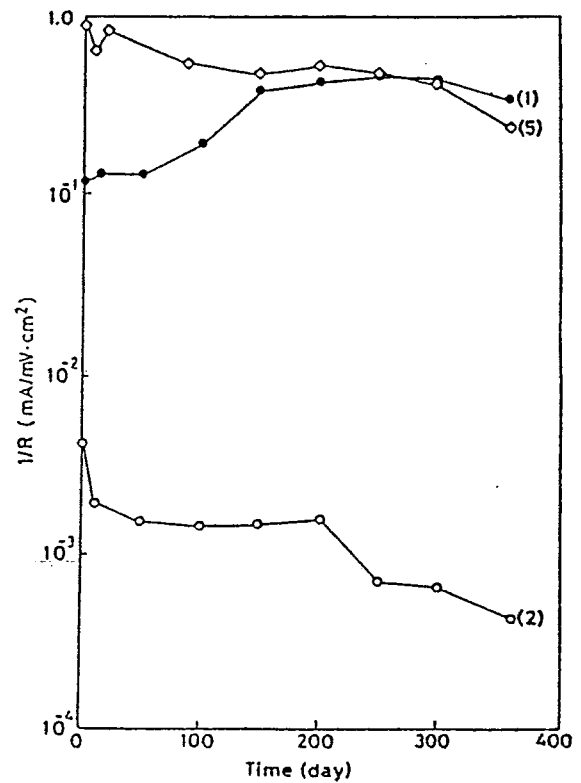
FIGURE 13 Polarization resistance vs. time curves of steel plates in sea sand.

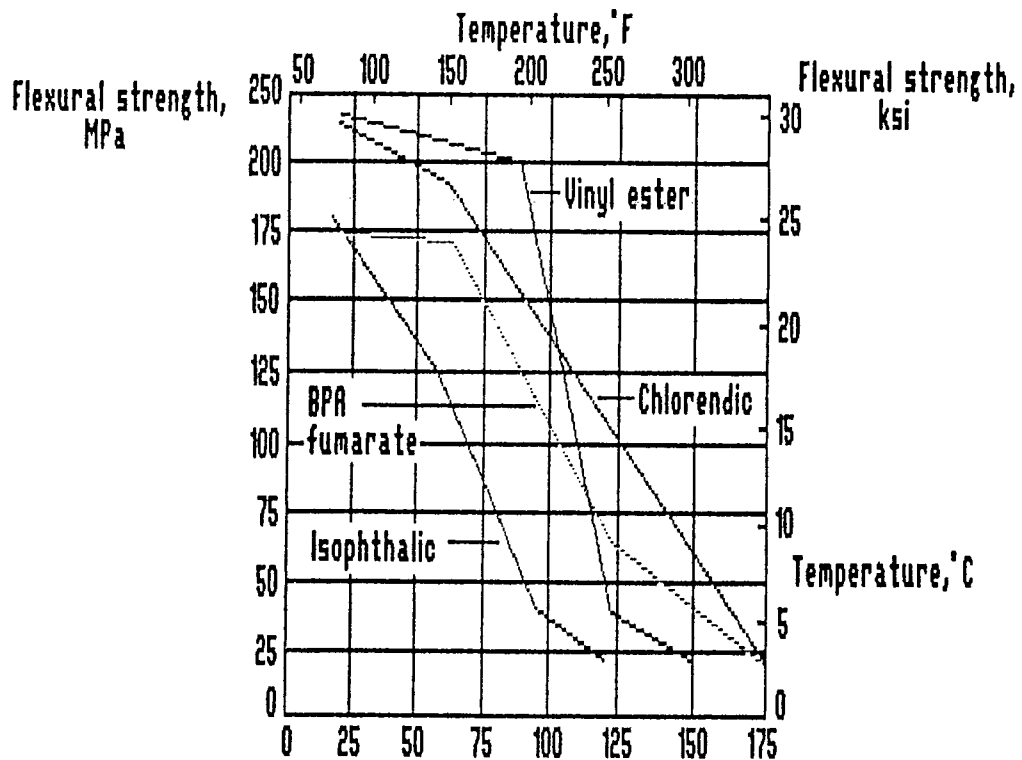
Figure: Flexural strength versus temperature, glass-polyester composites of 40% glass

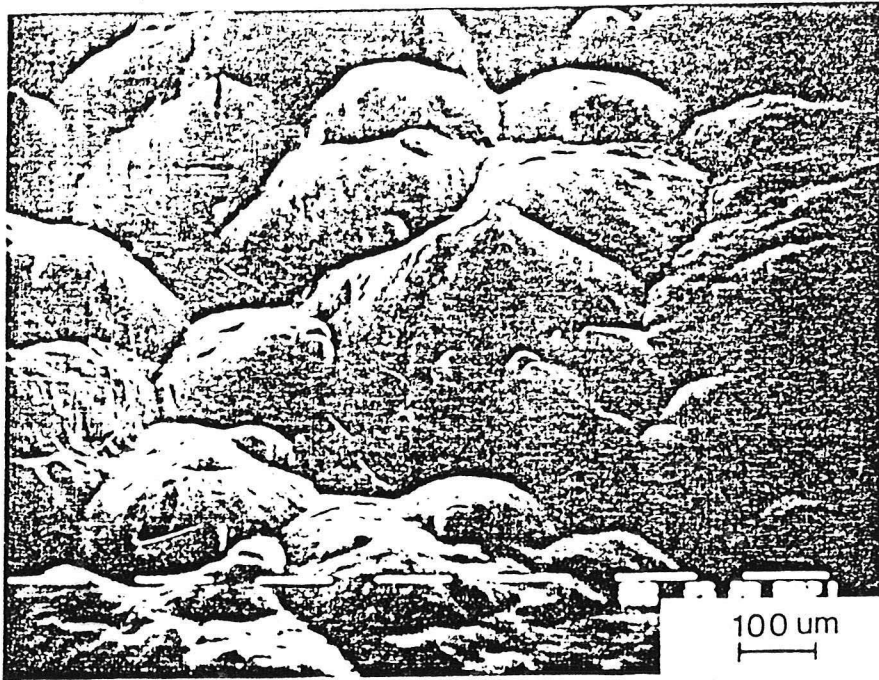
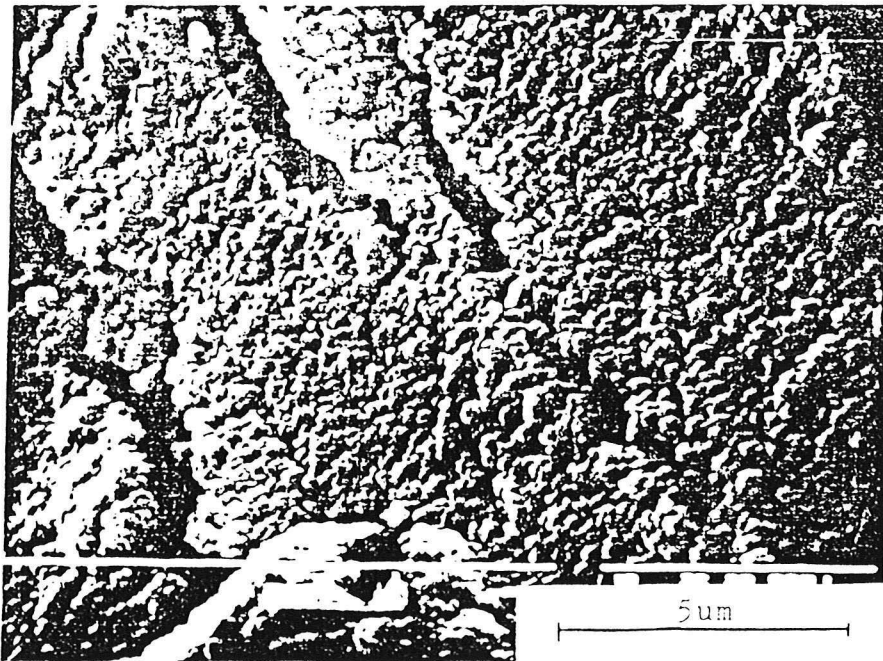
Fig. 1. Microstructures of corrosion product of Ni in 50 % O_2 - 1.5 % Cl_2 - Ar at 1000 °K.

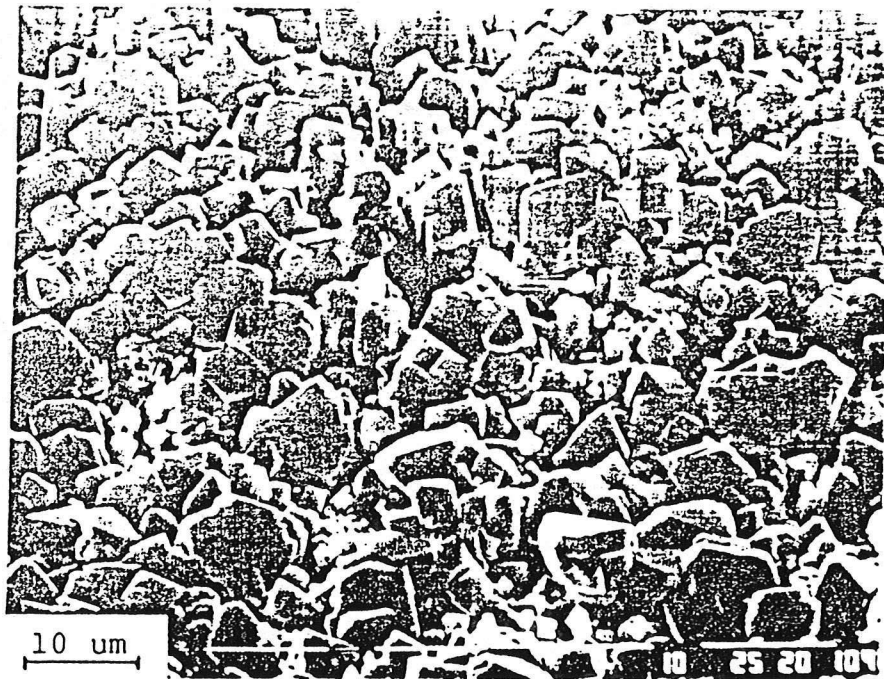
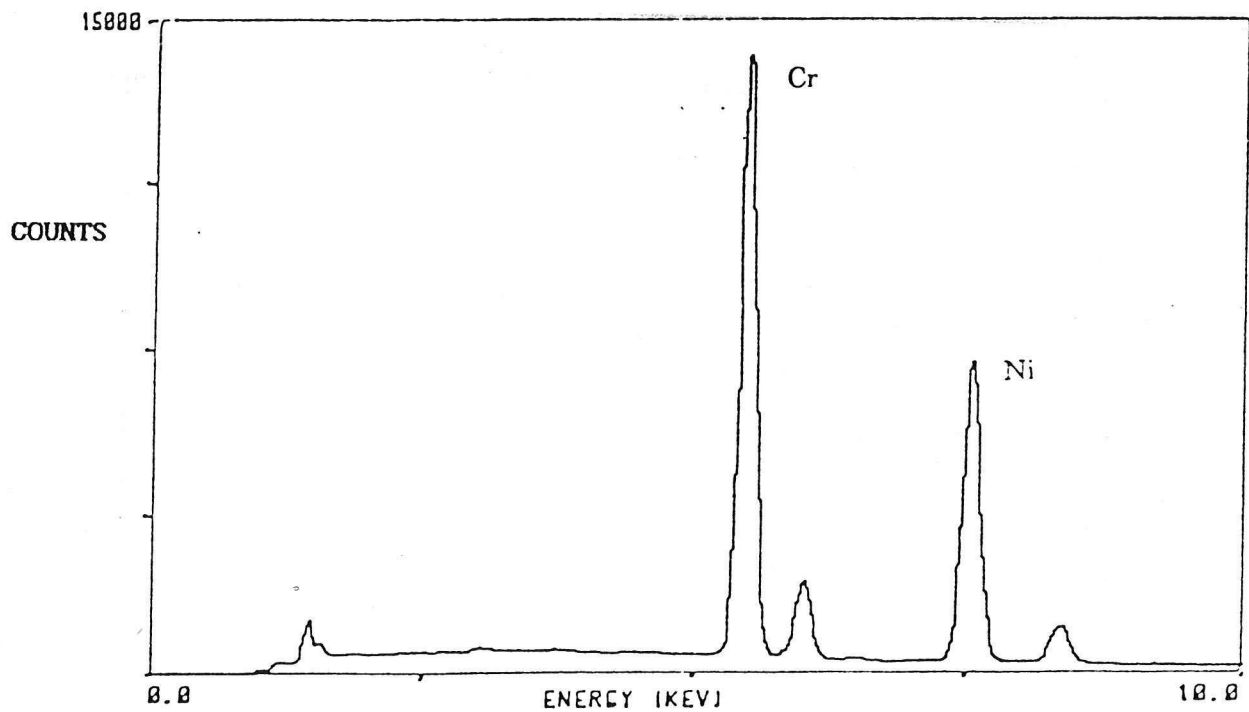
Fig. 2. Microstructures and EDX analysis of corrosion product of alloy C15 after 100 hours exposure to 600 ppm Cl_2 - Ar at 1100 °K.

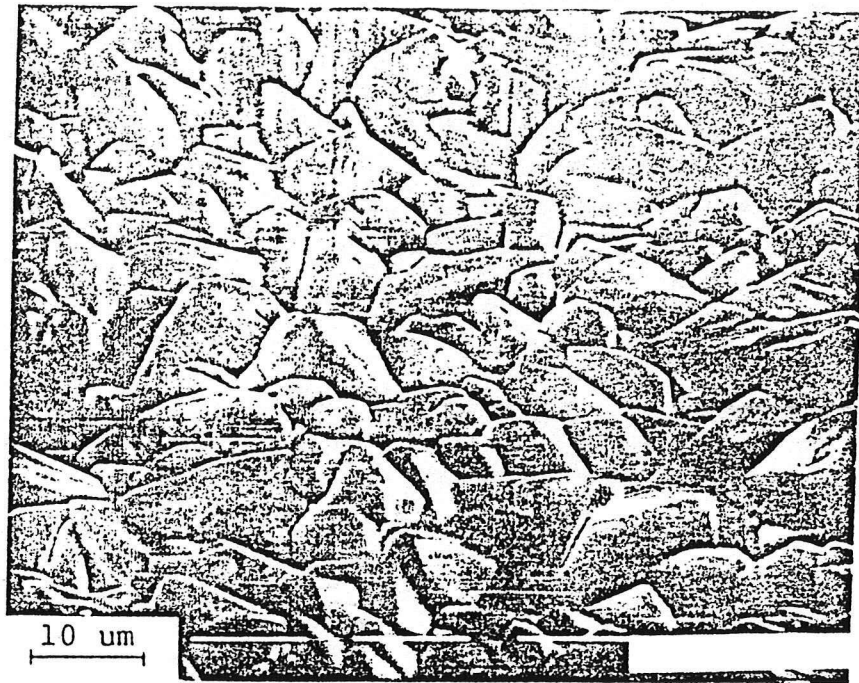
Fig. 3. Microstructures of corrosion product of alloy C1 after 24 hours exposure to 600 ppm Cl_2 - Ar at 1200 °K.

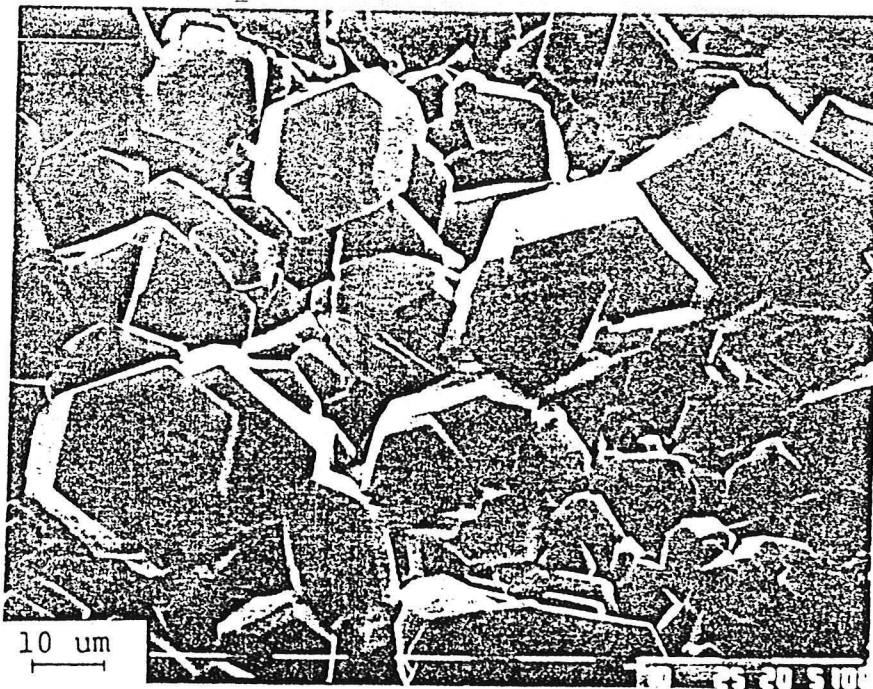
Fig. 4. Microstructures of corrosion product of alloy A1 after 24 hours exposure to 600 ppm Cl_2 - Ar at 1200 °K.

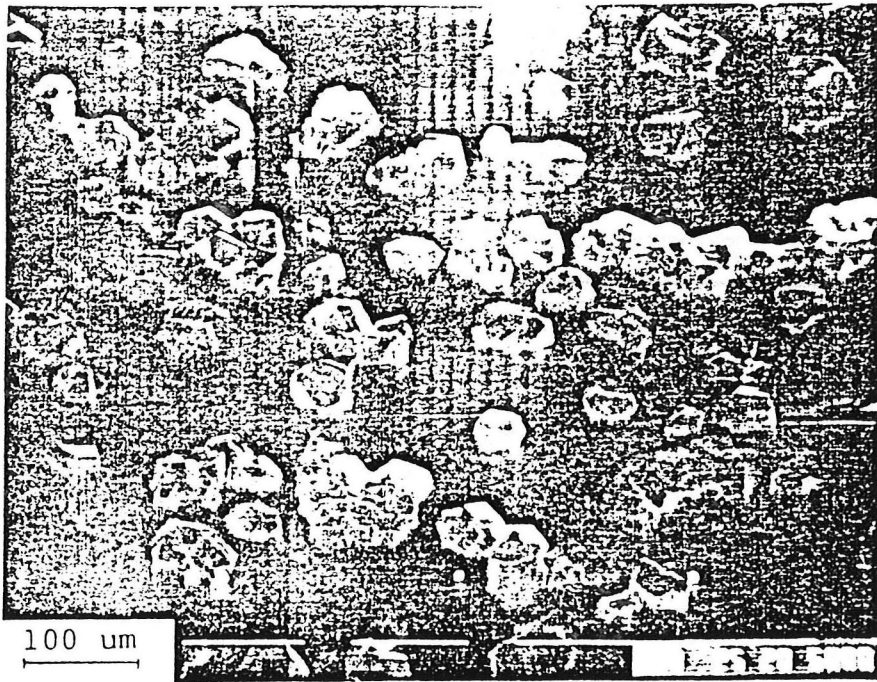
Fig. 5. Microstructures of corrosion product of alloy A5 after 24 hours exposure to 600 ppm Cl_2 - Ar at 1200 °K.

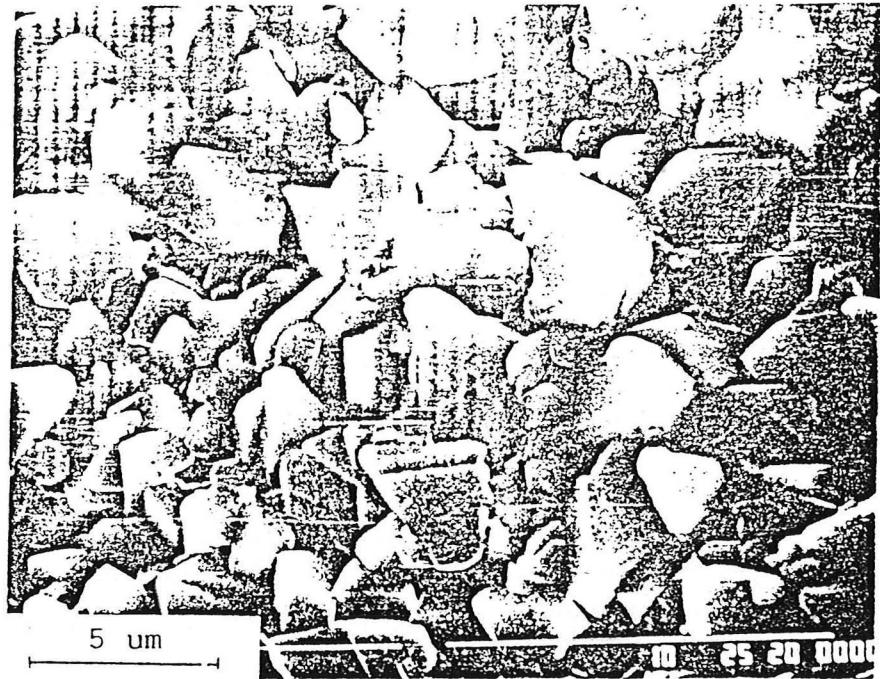
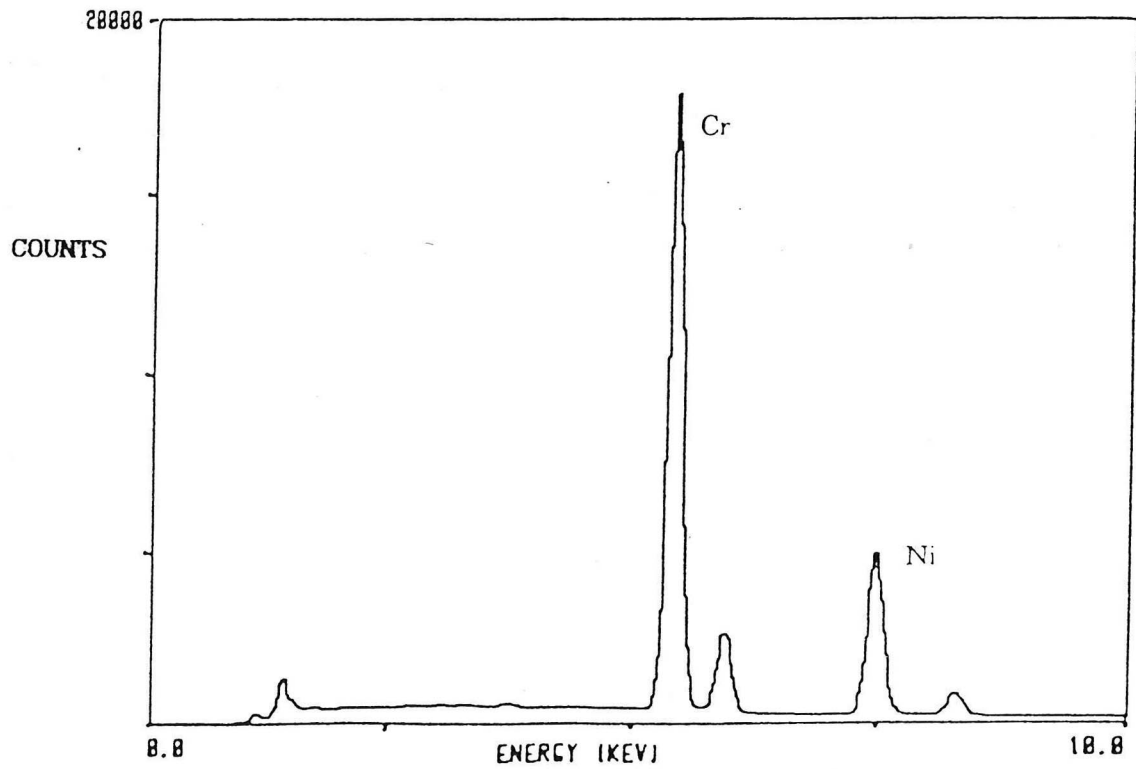
Fig. 6. Microstructures and EDX analysis of corrosion product of alloy C15 after 400 hours exposure to 20 % O₂ - 0.25 % Cl₂ - Ar at 1200 °K.

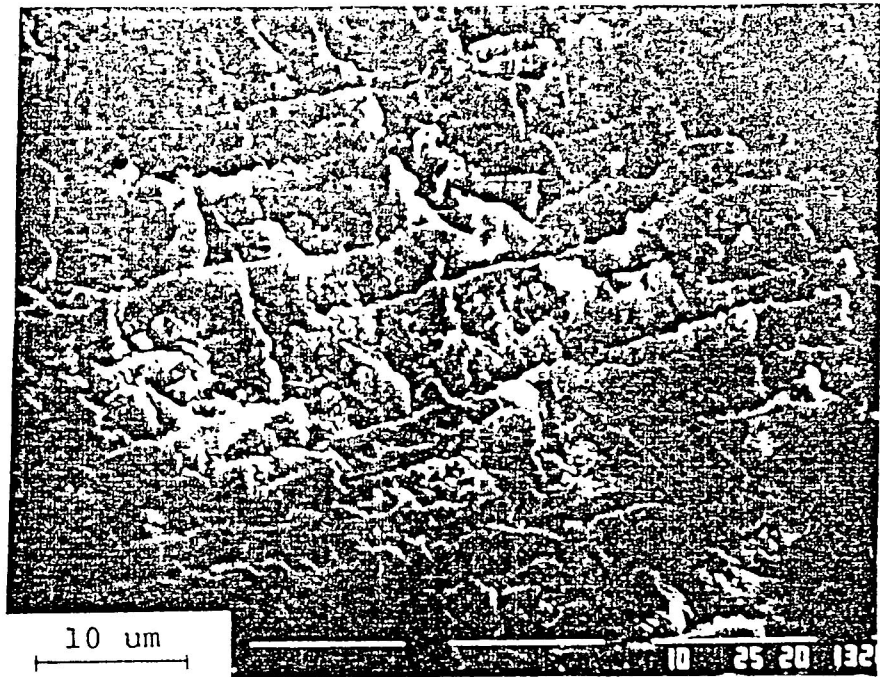
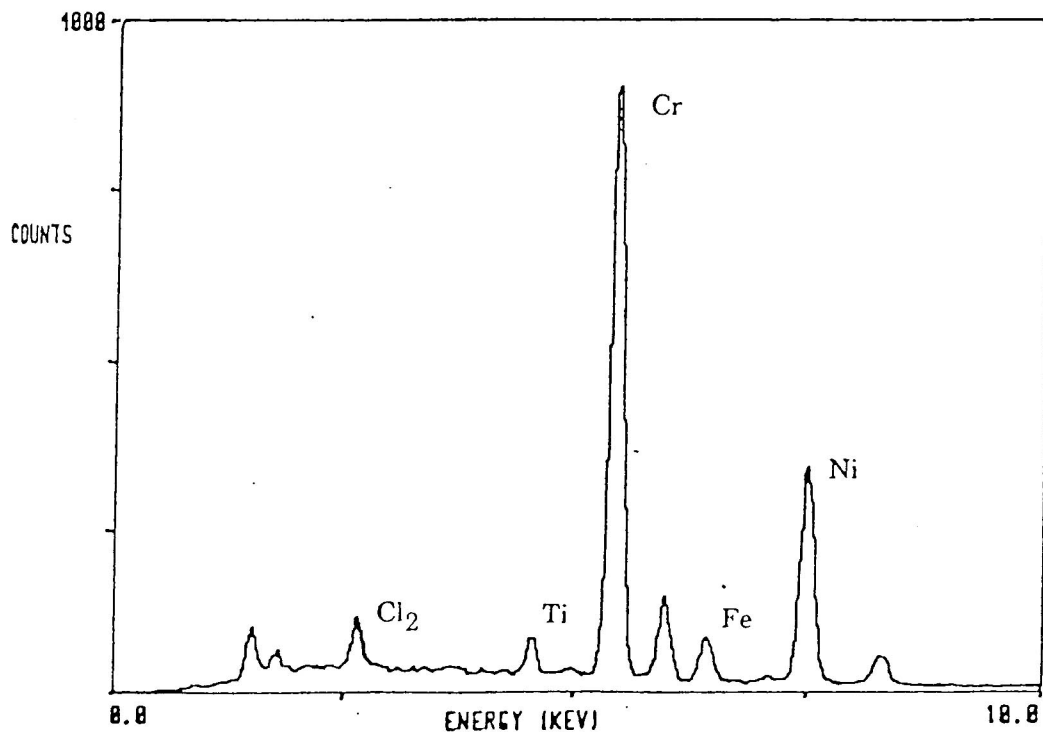
Fig. 7. Microstructures and EDX analysis of corrosion product of alloy 600 in 20 % O₂ - 2.8 % Cl₂ - Ar at 1200 °K.

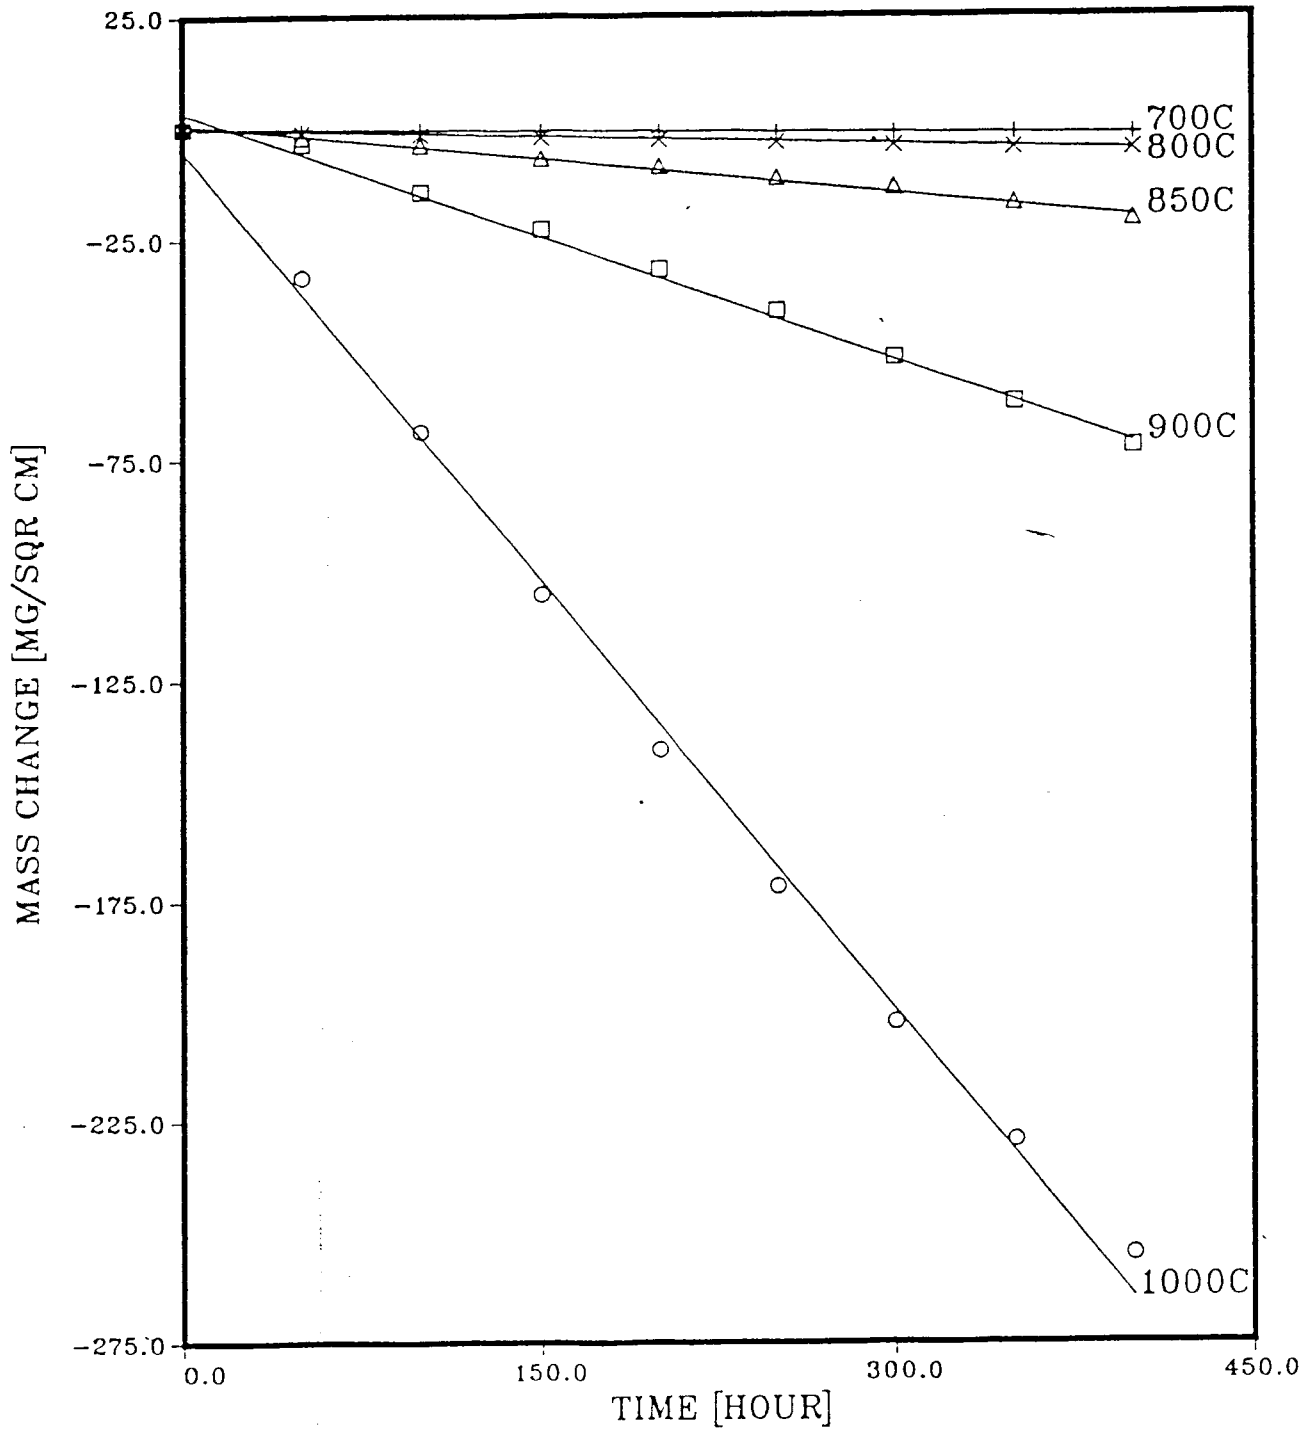
Fig. 8. Mass change of alloy 600 in 20 % O₂ - 0.25 % Cl₂ - Ar at high temperature.

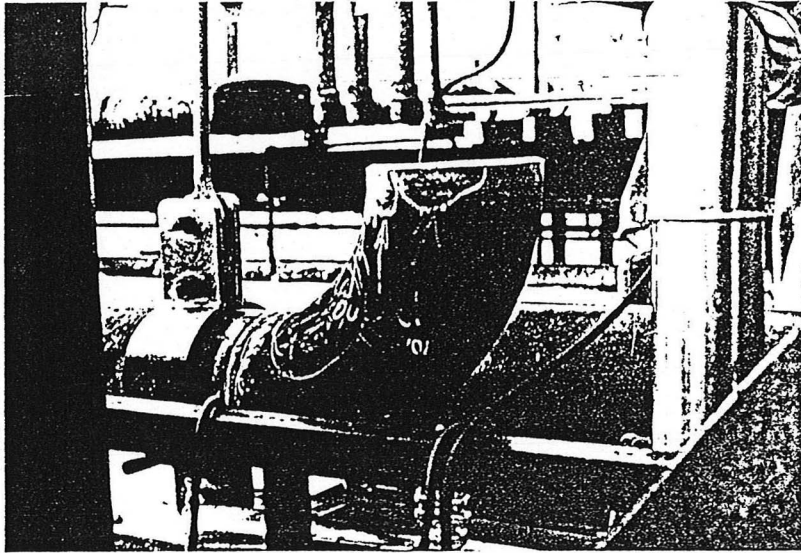
Figure 1 Run pipe between outlet R-1401 to E-1401 C

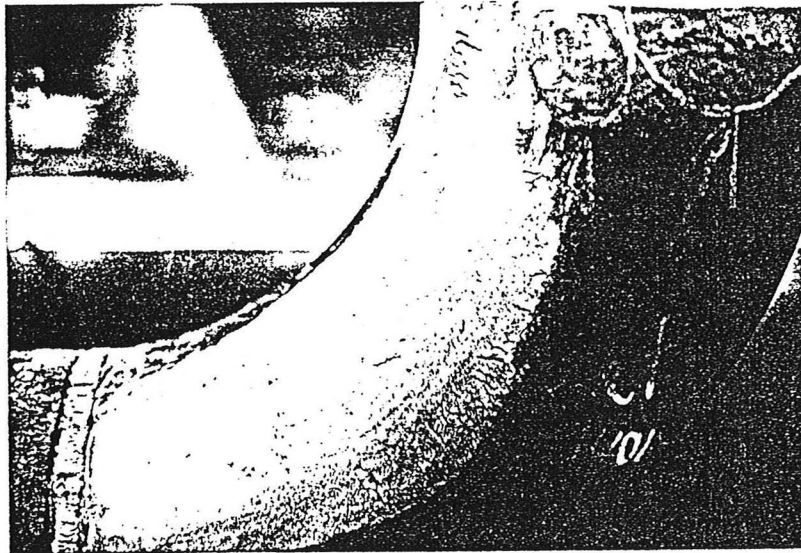
Figure 2 Close up of elbow in Figure 1 to show surface cracks.

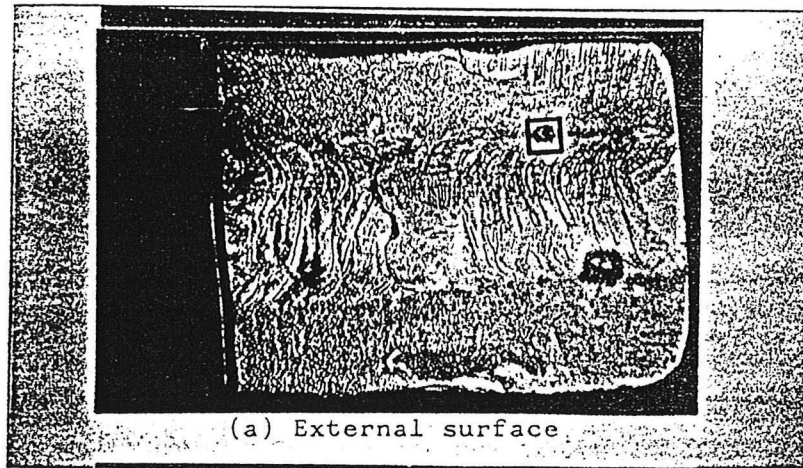
Figure 4 - (a) Dye-penetrant test on external surface giving defect indication.
(b) Dye-penetrant test on internal surface giving surface defect indication.
(c) Cut samples with arrows showing section plane for macro-examination. Note that "ref" was cut before test were carried out to avoid further contamination and also be used as a calibration reference for analysis.

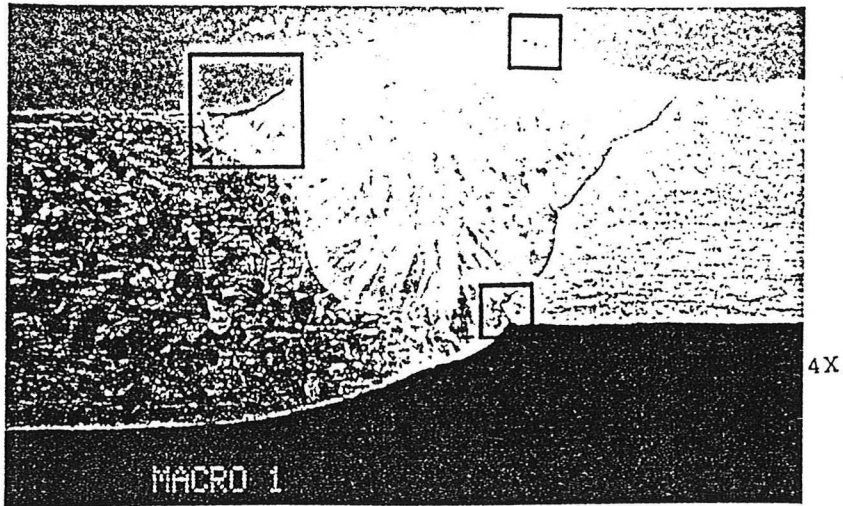
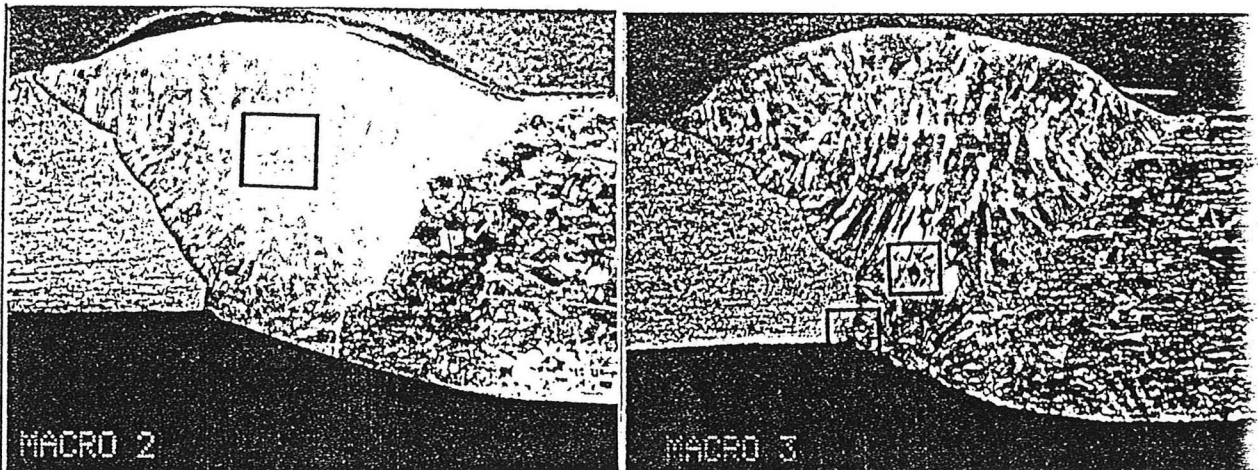
Figure 5 (a) - Macro-examination of weldment.

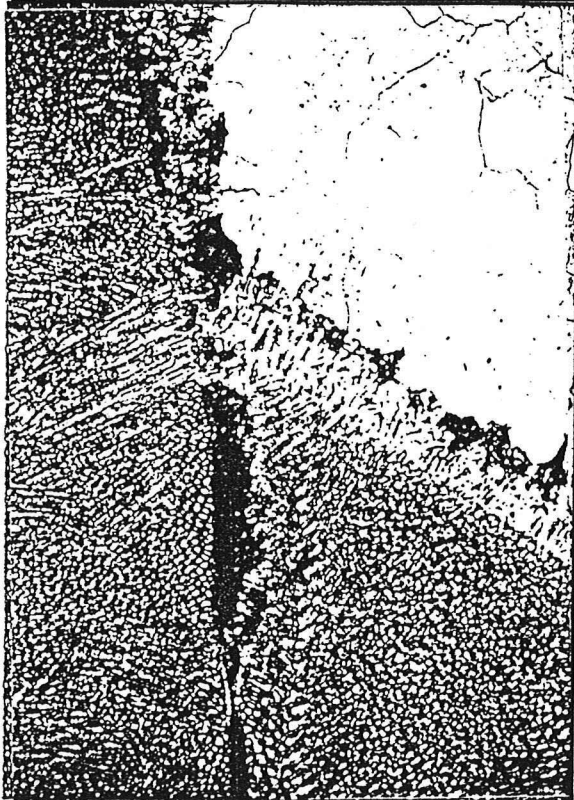
Location
A
200X

Figure 7 - Metallographic micrographs exhibiting defects at the fusion zone between the weldment and the 9mm thick pipe material. Besides root toe defect, intergranular corrosion is observed adjacent to the defect.

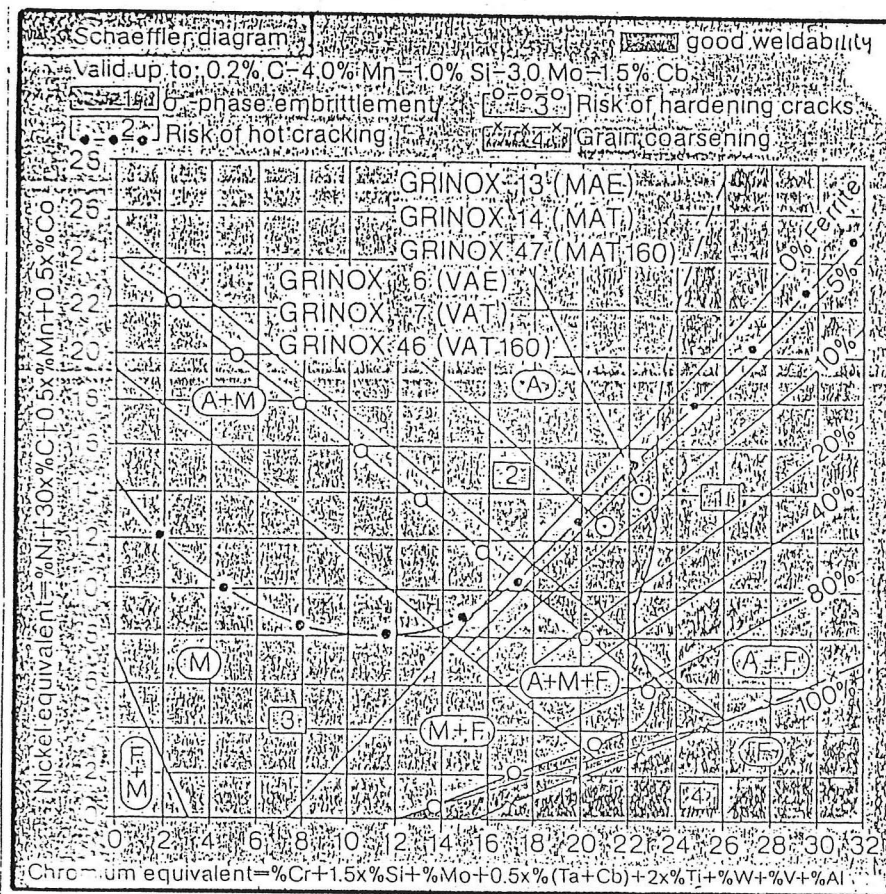
Figure 21. Schaeffler Diagram

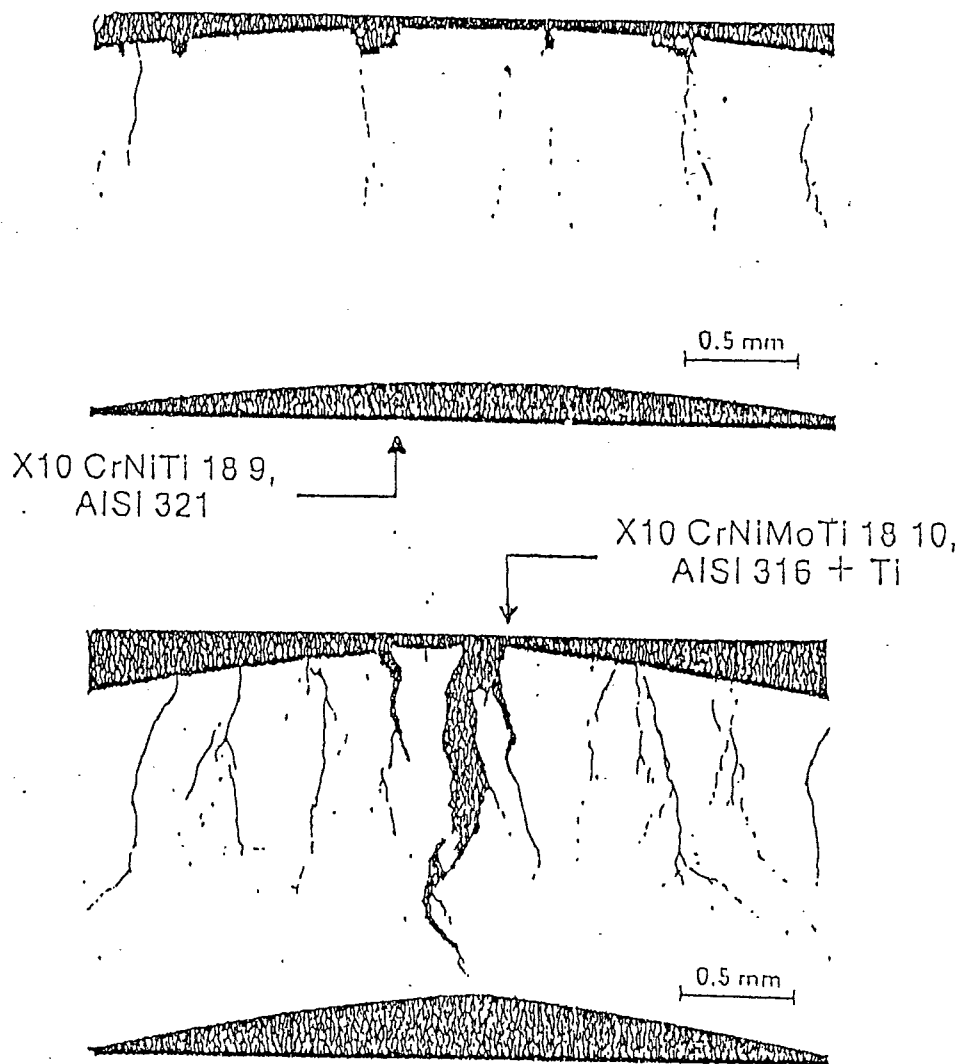
SCC Conditions: Autoclave, 150 C (300 F),
70 ppm O_2 , Exposure Time 8 Days
